AN APPRAISAL AND ANALYSIS OF BOILER PIPES IN AL-MUSAIB ELECTRIC POWER STATION

ABSTRACT

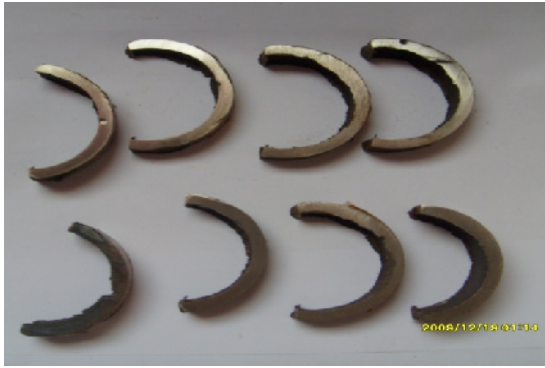
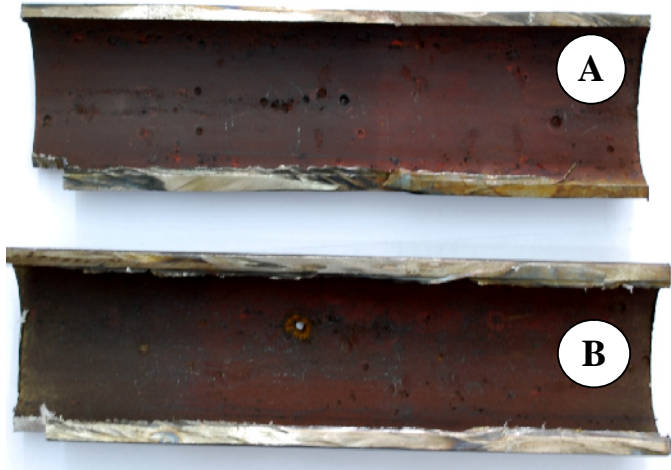
The manner in which each of the failed pipes failed was identical. **Figure 2** is a representative photograph of the appearance of the failed pipes. The failures appeared to have started at the inner surface of the pipe and propagated across the thickness.

Figure (2): A-Longitudinal cross section of damaged and undamaged boiler pipes.
 B- Half rings samples taken from each pipe.

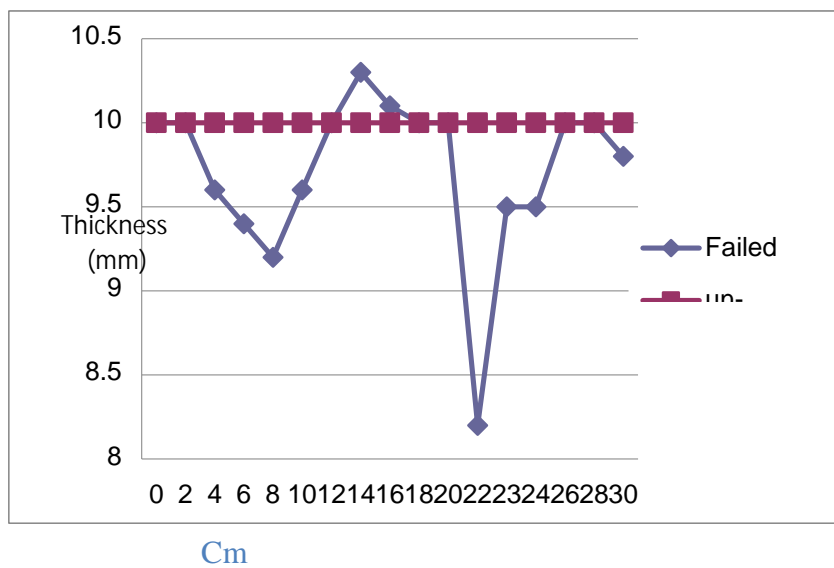
In this paper, the failed pipes have not burst but they suffer from a sever pitting corrosion and erosion. Measuring thickness along the pipe samples can give a clear indication about the corrosion-erosion along the steam side as can be seen in **figure (4)**.

Erosion of investigated pipes is so clear according to the figures above. The degradation in thickness along the pipe reflects the ideas about some expected kind of erosion has occurred. Pipe no.6/coil 92 had been eroded clearly in the locations (2-12 cm) and (20-26 cm) in the 30 cm long investigated.

Figure (4): Thickness measurement along the failed and un-failed pipe no.6/coil92.

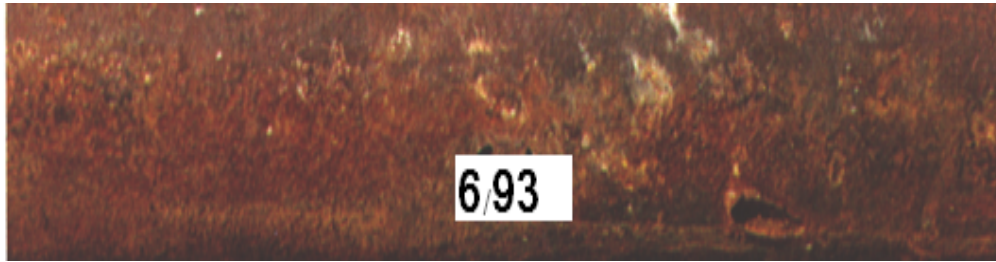
Tubes 6/coil93 and 7/coil48 had few crack openings and deep pits around it. From the **figures** (5), it is evident that pitting started at the surface of the tube near the crack and progressed downwards undercutting the surface. It was also observed that depth of the pit increased as one moves away from the crack. No chemical attack was found on the steam-side of the tube wall.

One of the roof panel tubes of boiler 6, designated as 6/93 in **Fig.** (5) had a swollen portion with many un-regularities and pitting on it. Longitudinal section of the failed area, cleaned with inhibited 3% hydrochloric acid solution, revealed that the fine cracks had initiated at the steam -side of the tube. Some of the cracks had crossed the entire thickness of the tube and had opening at the other side.

Figure (5): surface of pipe (6/93).

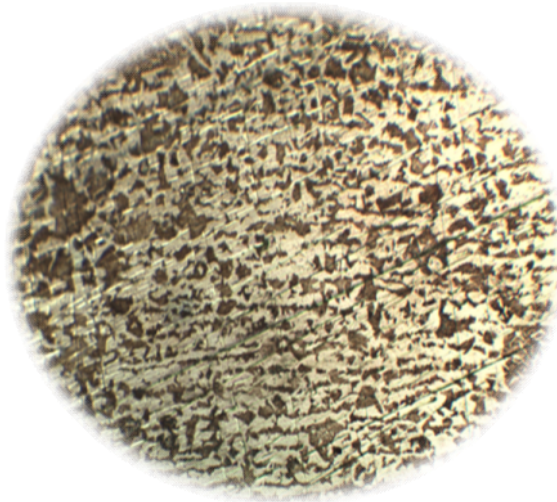
Figure (6): Micrograph structure of the un-failed pipe no. 6/93, (200X)

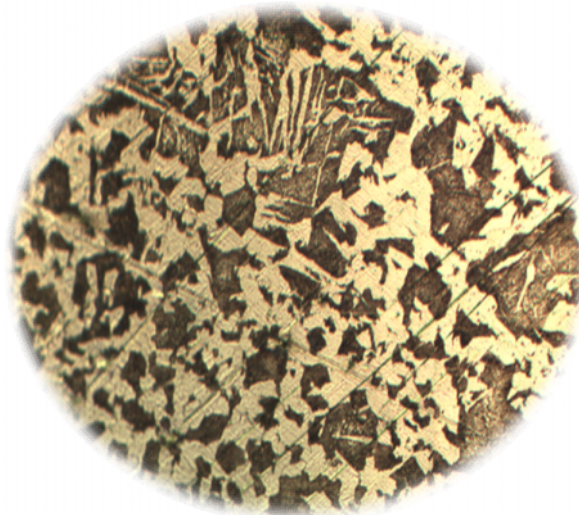
Microscopic studies of cross-section of failure zone of boiler tube 6/93 and 7/48 show quenched microstructure with small amount of carbides present at the grain boundaries (**Fig. 6** and **7**). On comparing the above microstructures of failed area with un-failed area of tube 6/93, 7/48, the former appears as quenched overheated microstructures.

This shows that the exposure temperatures of the above failed areas have exceeded the lower critical temperature and were exposed to this temperature for quite long time. Knowing that, the strength of steel is nearly constant up to about 454°C.

Figure (7): Micrograph structure of the failed pipe no. 6/93, (200X)

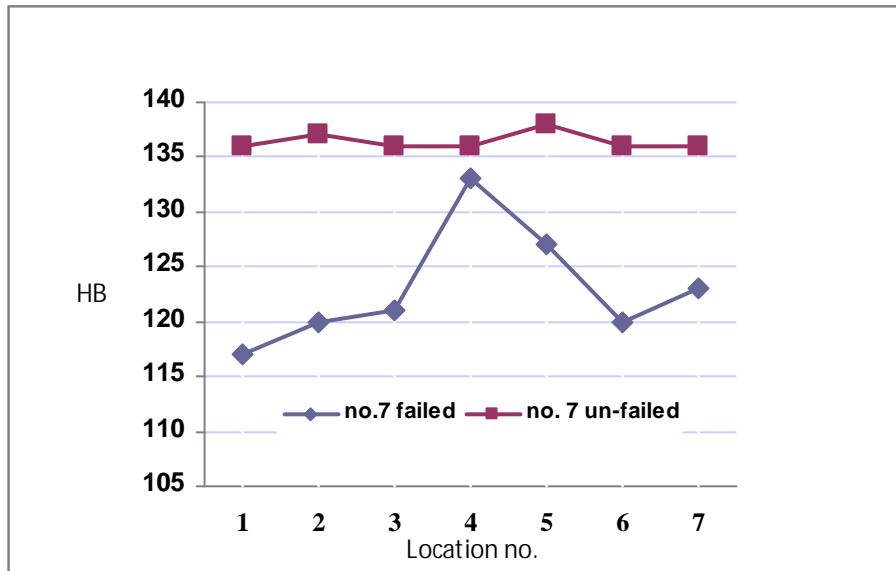
It is clear from both figures down that a noticeable difference between the failed and un-failed hardness results. In **figure (9)**, pipe no.7 in coil 48 shows a distinct difference in hardness numbers, gave a clear picture about what is going on in this pipe. The first indication put that, a softening phenomenon has occurred clearly in this failed pipe. Furthermore the swinging of hardness numbers

and their drops in comparison with the un-failed pipe gives an indication that, the pipe has subjected to an overheating during its operation.

Figure (9): Comparison between hardness results of failed and un-failed pipe no. 7/coil no.48

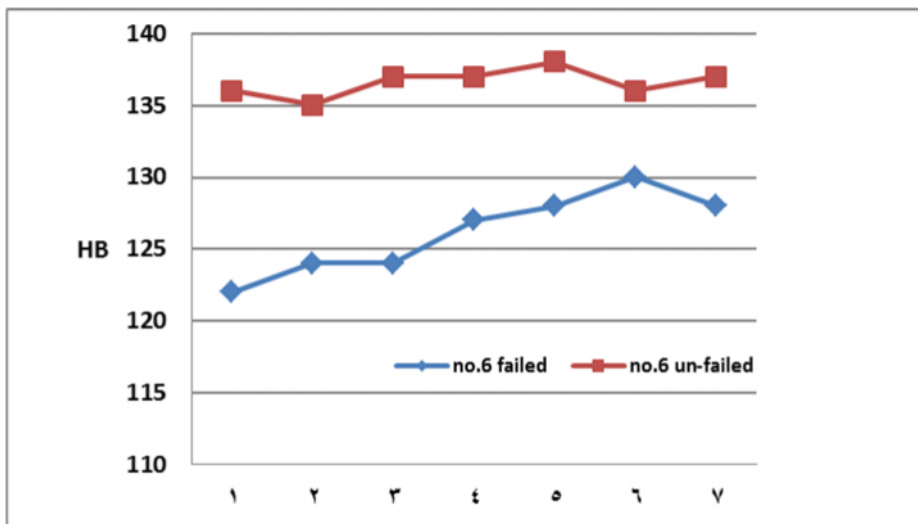
Hardness numbers reflects to some extent, the change in the microstructure along the cross section of boiler shown in the **figure (9** and **10)**. The following figures show a comparison between the hardness numbers of failed and un-failed of the two pipes adopted in this project.

Figure (10): Comparison between hardness results of failed and un-failed pipe no. 6/coil no.93
