## Study The Causes of Failure of Furnace Wall Tube In Thermal Power Plant (Part I)

The failure of furnace wall tubes, boiler 6 –Najibia power station on March 2005 leading to plant shutdown was investigated. The present work deals with the experimental investigation to recognize the causes of failure. These included:1-Determination of scale density and its compositional analysis, 2-Spectrometric analysis of tube alloy material, 3-Mechanical testing of tubes material and 4-Examination of microstructure of the alloy.The results indicated that the recorded internal scale density  $\sim 45 \text{ mg/cm}^2$  may interfere with the heat transfer process leading to overheating. The loss of some alloying elements due to excessive heating reduces the strength of the alloy. An increase of hardness was detected to (720-800 HV) at the failed side which reflects the effect of metal hardening. Furthermore,the microstructural examination indicated the phase transformation of the pearlite to the martensite which confirmed the hardening effect leading to tube brittleness then rupture thereafter.The probable causes of tube failure were discussed.

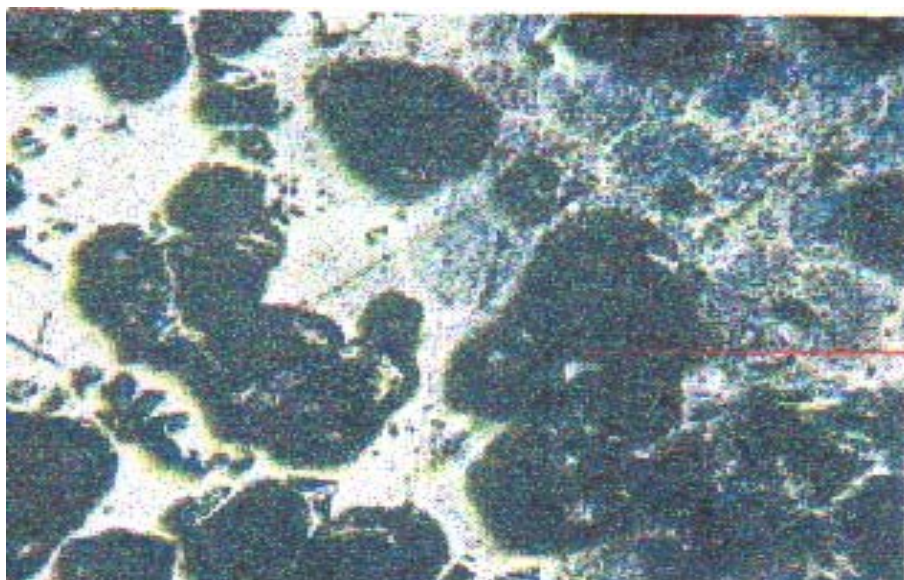
**Corrosion under scale:** The presence of scale layer on tube internal surface hidden crevice corrosion underneath (**Plate 1**). These crevices are concentrated on the cold sides more than that on the hot sides. This could be related to the thinner scale layer of the cold side compared to that of the hot side. Such layer may permit diffusion of the aggressive ions from boiler water to the metal surface which resulted in crevice corrosion (Ateya et al, 2000). Moreover, some of the crevices merged together and aligned themselves at the crack root. These crevices act as stress-raisers and serve as crack initiators.

**Plate 1** -Surface feature of the failed tube ( steel 20 )boiler 6 as received-before cleaning ,showing the deposition,200x .

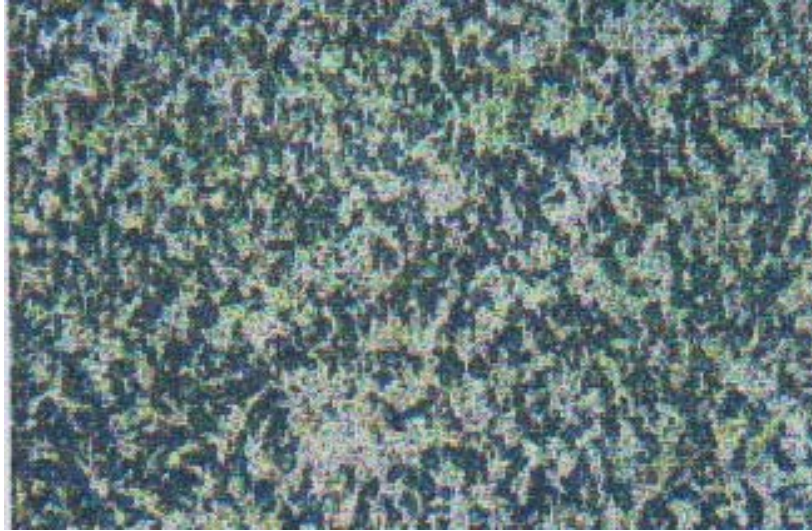
**Metallurgical Examination:** Undoubtedly, there is a remarkable correlation between the mechanical properties and the alloy composition in terms the allotropic forms (Raman and Petkovic 1981). It was found that the hardness increased in the bulged-ruptured region of the fire side (hot) of the tube wall to higher values of 720-800 HV compared to the hardness values of 136-147 HV observed in the opposite side (cold region). The hardness of the intact tube was in the range of 150-185 HV (see **Table 4**). For instance, the new tube showed normal hardness values of 150- 230 HV with the normal structure of pearlitic steel (**Plate 2**).

**Plate 2-** Normal microstructure of the intact new tube ( Steel 20), boiler 6 showing the two phases of ferrite and pearlite ( HV 175 ), etched by nital,200x .

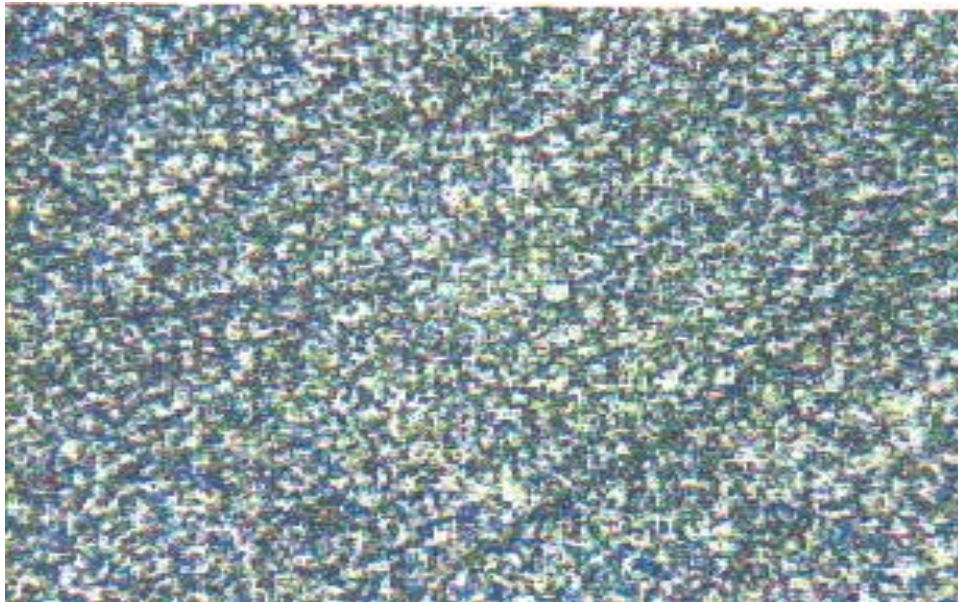
In the meanwhile, the the cold-side of the failed region showed no significant alteration of hardness and with normal structure of the pearlitic steel (**Plate 3**). The microstructural examination of the failed region at the bulged area revealed a phase transformation of the pearlitic steel to the martensite i.e. the hardest phase of steel (**Plate 4**). These observations were found in good agreement with the actual values of the hardness of martensite that was reported within the range of 680- 820 HV (Pollack, 1981).

However, the plastic deformation obviously resulted from excessive firing to a higher temperature than tolerated values. While the metal hardening possibly resulted from rapid cooling rates of the overheated tubes from (50°C above the critical hypoeutectoid temperature, 723°C) to about 200°C within a very short time interval which favored the formation of the martensite (Askeland 2003).

**Plate 3-** Microstructure of the failed tube ( steel 20 ) boiler 6 hot-side showing phase transformation to martensite ( HV 720 ), etched by nital , 200x .
