The Evaluation of Corrosion Problems In Condensate Return Lines –South Refineries Company

N. J. Hamadi* , G. A. K. Hassan** and A. A. Al-Shaheed**

**South Refineries Company.

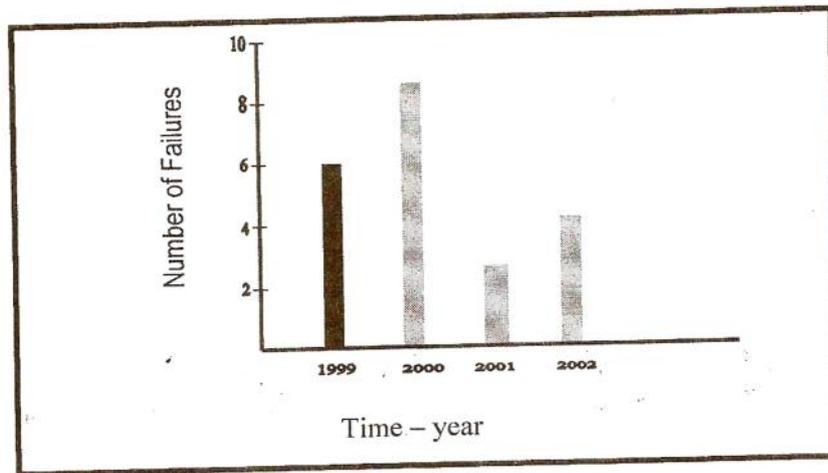
condensate from 10 branches of different diameters tubes. The header is located horizontally between unit No.700 and 800. A partial replacement for the failed regions were undertaken. Unfortunately, the leakage appeared after one month of maintenance. The frequency of the failures occurred during 1999-2002 were indicated in Fig. (1).

Fig. (1) -Represent the number of failures during the period 1999-2002

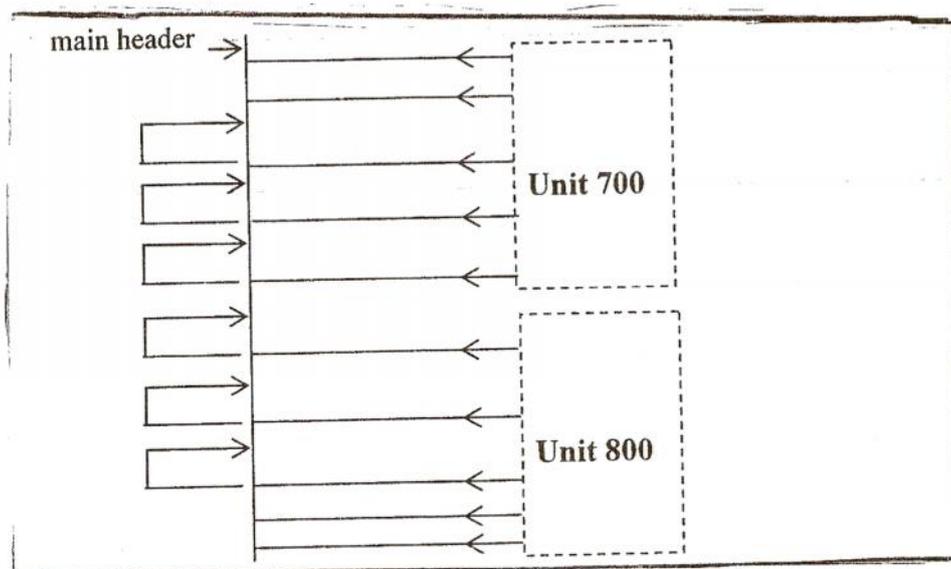
Inspection of the condensate returns main header 75 mm diameter, 60 m length and 5 mm thickness showed heavy leakages which received the

Fig. (2) – Location of the failure occurred in the main header condensate return lines-South Refinery Company.

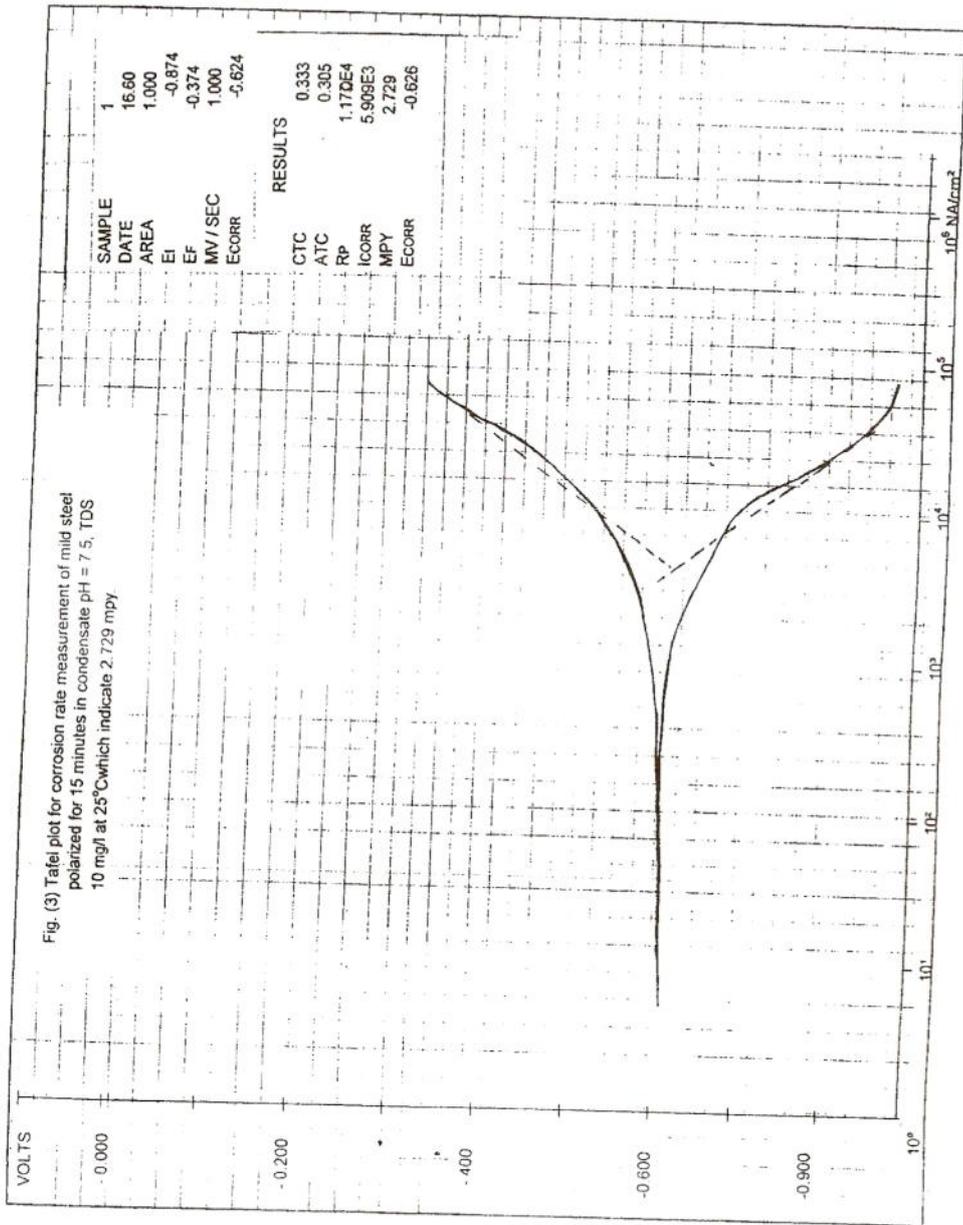
indicated that condensate showed relatively low corrosion rate (2.7 mpy) compared to that observed with raw water (6.5 mpy), refer to Fig. 3 & 4 . However , although the condensate in reality showed low corrosivity to the metallic surfaces in the short term experiment. But, practically it did not confer sufficient protection against corrosive agents such as H^+ , O_2 , CO_2 in the long term exposure (Hochheimer 2000).

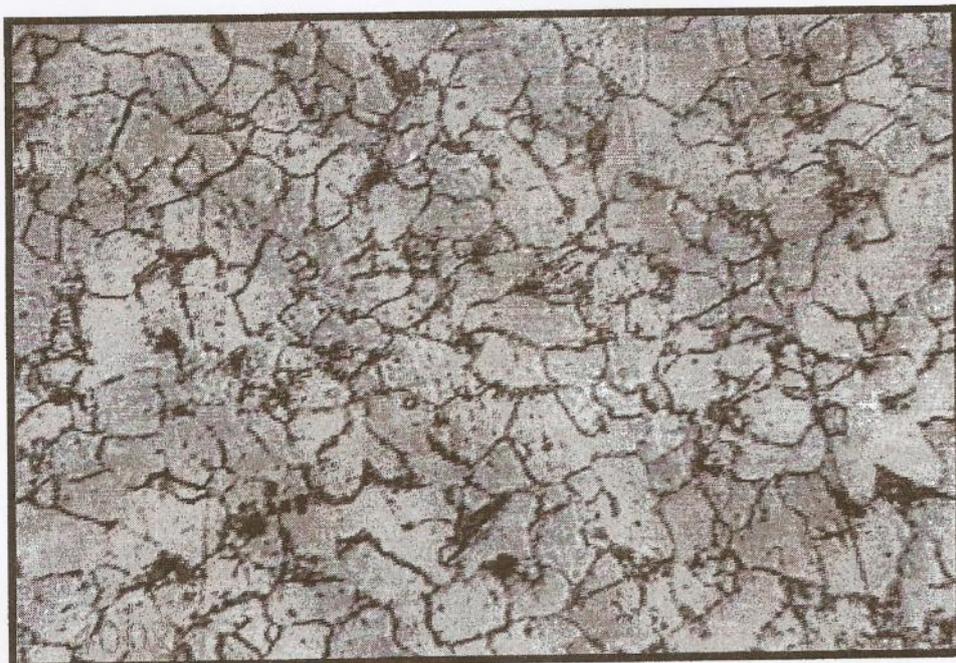
Microscopic examination: The results of microscopic examination of the corroded area (specimen 1) showed that pits are varying from single pit holes to a wide spread attack approaching uneven localized pitting corrosion (see plate 1). The intact area adjacent to the corroded area (specimen 2) showed a distortion of the micro structure to the extent that the ferrite incorporate very low percentage of pearlite. Plate 2 indicate clearly the phase change of steel micro structure (Pollack 1981).

Plate 2- Distored microstructure of mild steel (106B) showing the phase change ,specimen(2) ,etched by nital,400x.

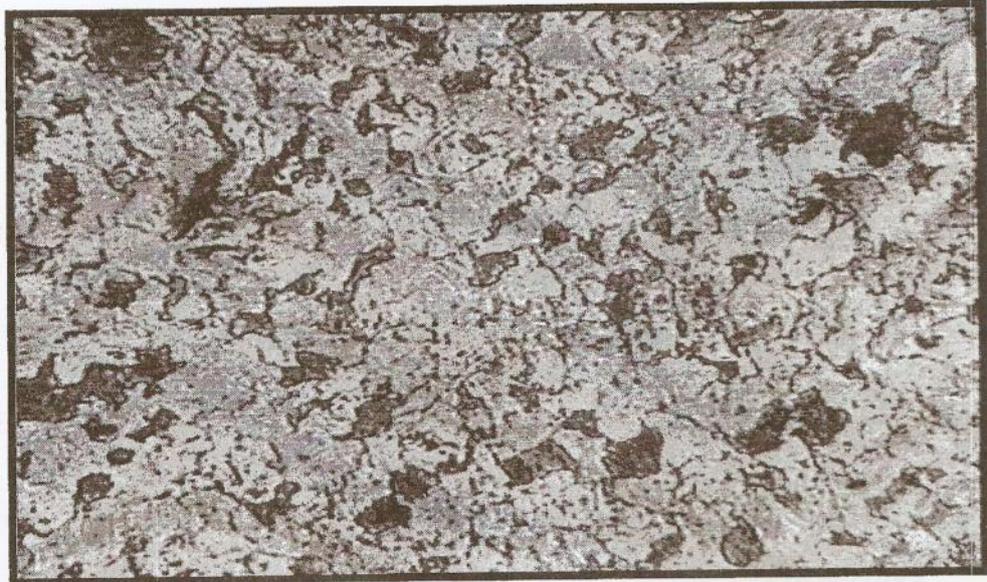
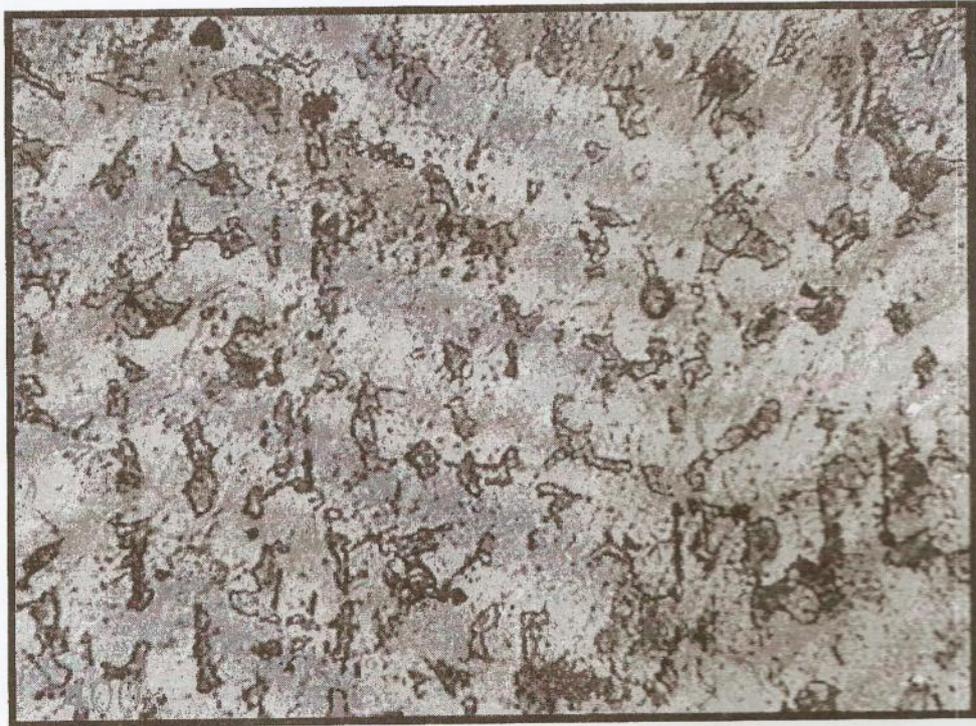
The intact cross sectional area (specimen 4) showed that there was no evidence of microstructural changes as evidently appeared in Plate 4(a & b). **Corrosion rate measurements:** from the results obtained from the polarization of the pipe specimens on an electrochemical cell, it was

Plate 4(a&b) - Microstructure of mild steel (106B) showing the normal structure of the two phases of steel, specimen(4), etched by nital ,400x .
