# Seismic Refraction and Cross-Hole Techniques for Investigate the Top Soil and Water Table Beneath the High Pumping Station Hall of Al-Hussian water Supply Station, Kerbala, Iraq

\*Ahmad, S. Al-Banna, \*\*Ammar, J. Al-Khfaji and \*\* Esam, S. Banno \* Department of Earth Science, College of Science, University of Baghdad \*\* National Center for Construction Laboratory (NCCL) أستكشاف التربة و مستوى المياه الجوفية باستخدام الطرق الزلزالية الانكسارية السطحية والبئرية تحت قاعة محطة الضخ في مشروع ماء الحسين في كربلاء –العراق \*أحمد شهاب البناء \*\*وعمار جاسم الخفاجي \*\*و عصام سعيد بنو \*قسم علوم الارض- كلية العلوم –جامعة بغداد \*\* المركز الوطنى للمختبرات الانشانية

## Jornal of Kerbala University, Vol. 4 No4 Scientific, December 2006

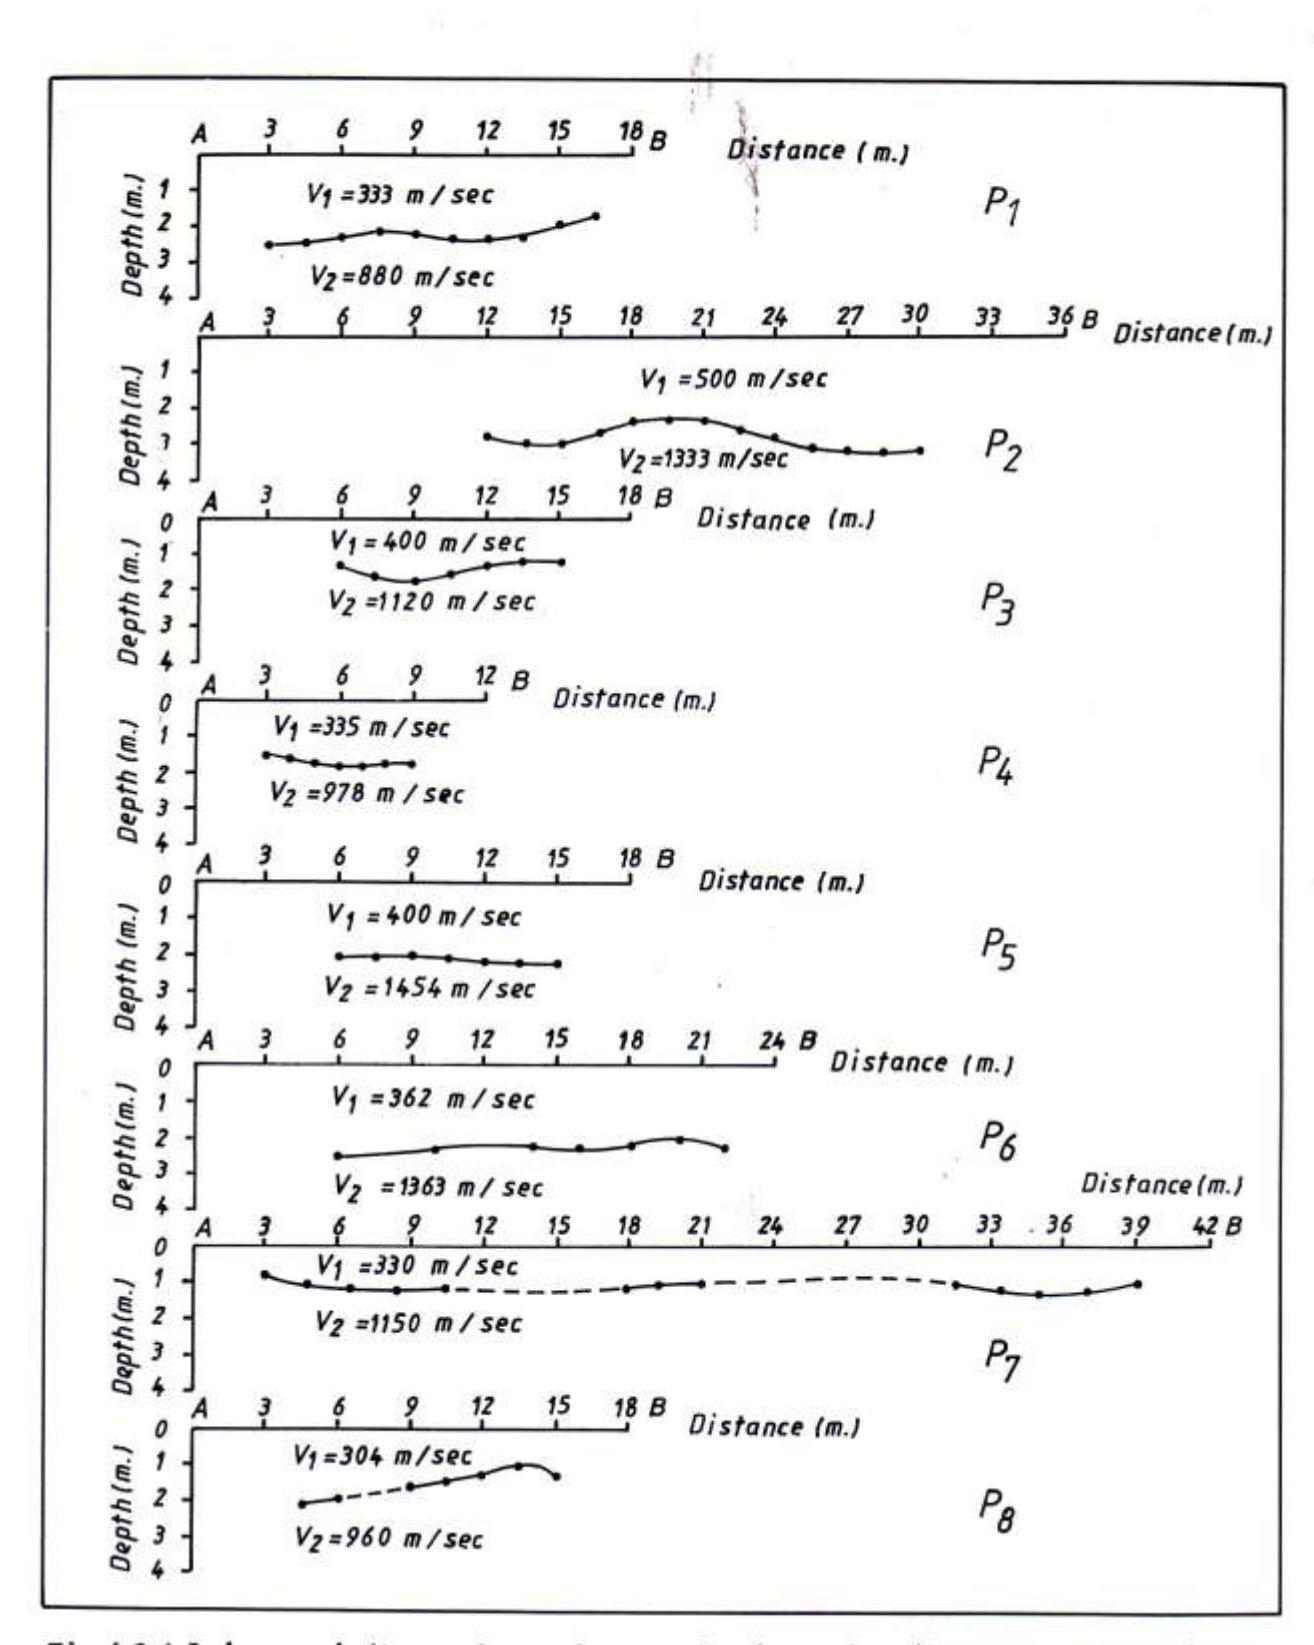
Mainly two methods are applied, in addition to the least square (critical distance and intercept time) method, to interpret the seismic measurements. These are the Plus-Minus and ABC methods, (Hagedoorn 1959, Cummings 1979, Dampaney and Whitely 1980, Sjogren 1984). It was found that the velocity of the top layer (first layer) range between 304-500 m/sec, while the second layer velocity range between 878-1454 m/sec. The Plus-Minus and ABC interpretation methods show nearly similar results, (figures 2and 3). The depth of refractor detected by seismic refraction method varied along the measured profiles. This may depend on variation in the soil elastic properties beneath each geophone. Generally the depth of the refractor found to be range between 1.0-2.5 meters along profiles 1, 2, 3, 4, 5, 6, 7 and 8.

Fig.(2) Interpretation of surface seismic refraction survey using plus-minus method for profiles 1, 2, 3, 4, 5, 6, 7 and 8 at the pumping station of Al-Hussain water supply station, Kerbala.

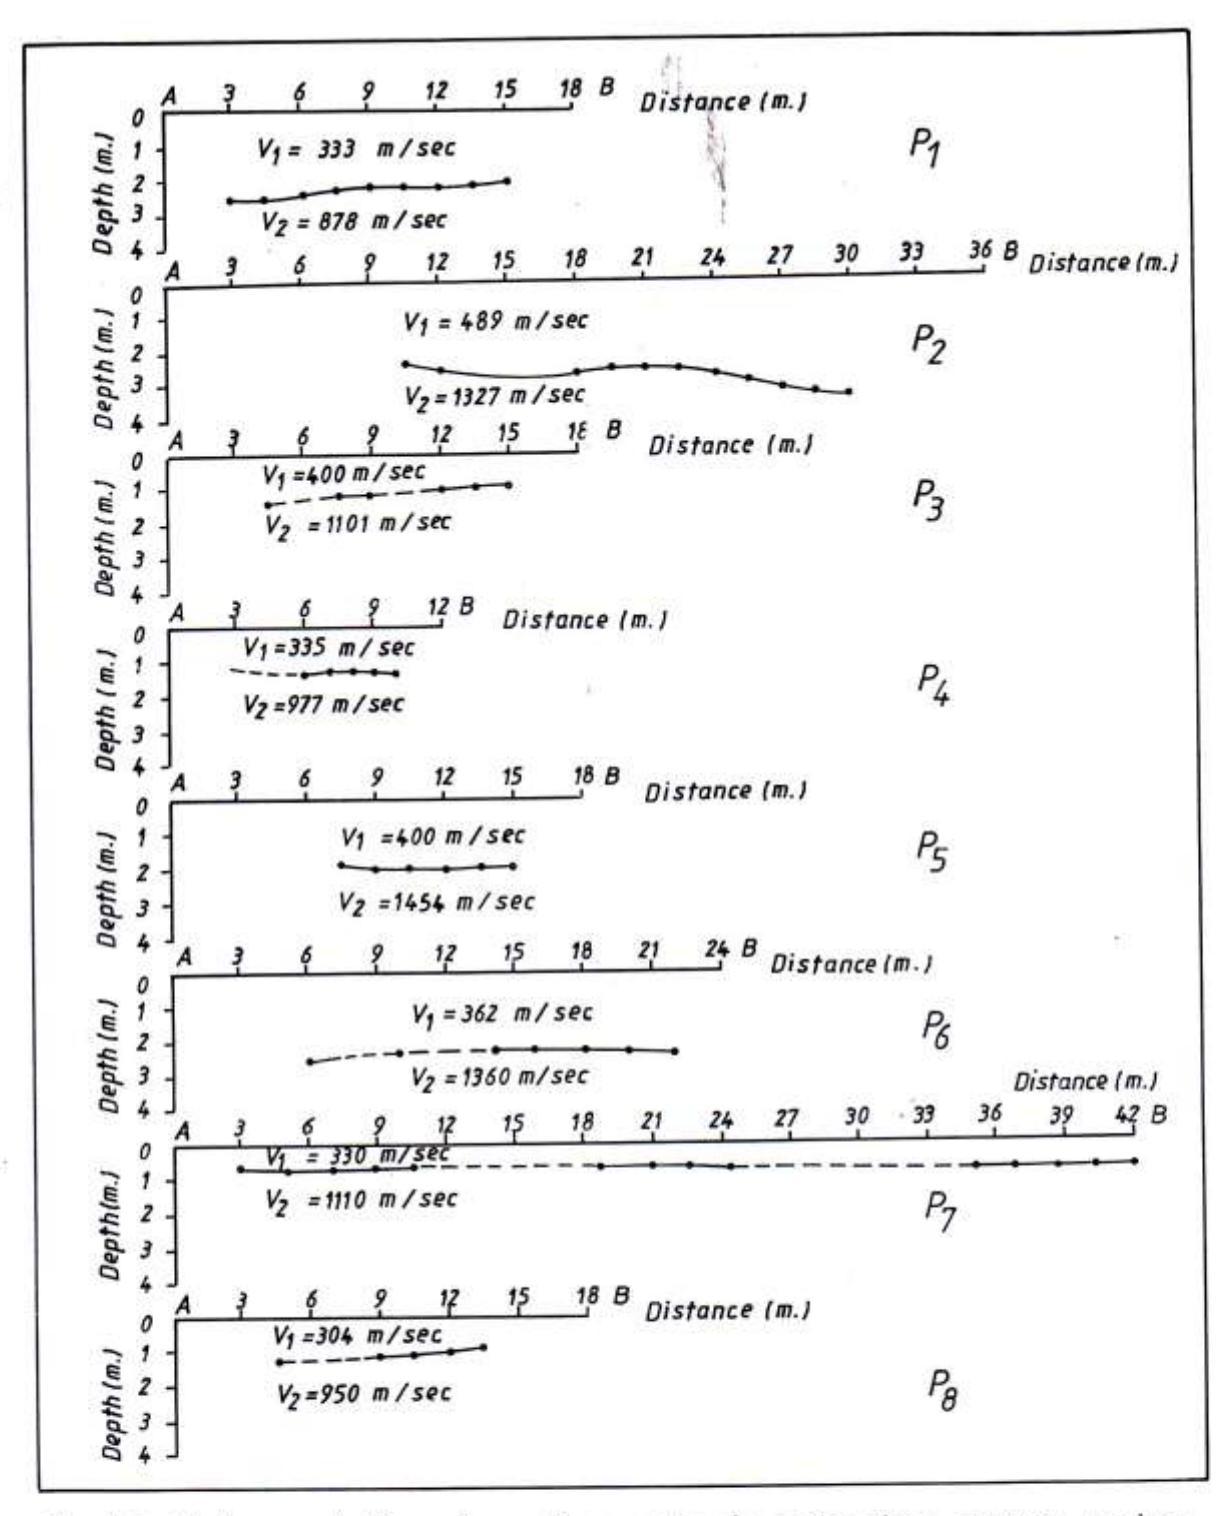
Fig. (3) Interpretation of surface seismic refraction survey using ABC method for profiles 1,2,3,4,5,6,7 and 8 at the pumping station of AL-Hussain water supply station, Kerbala.

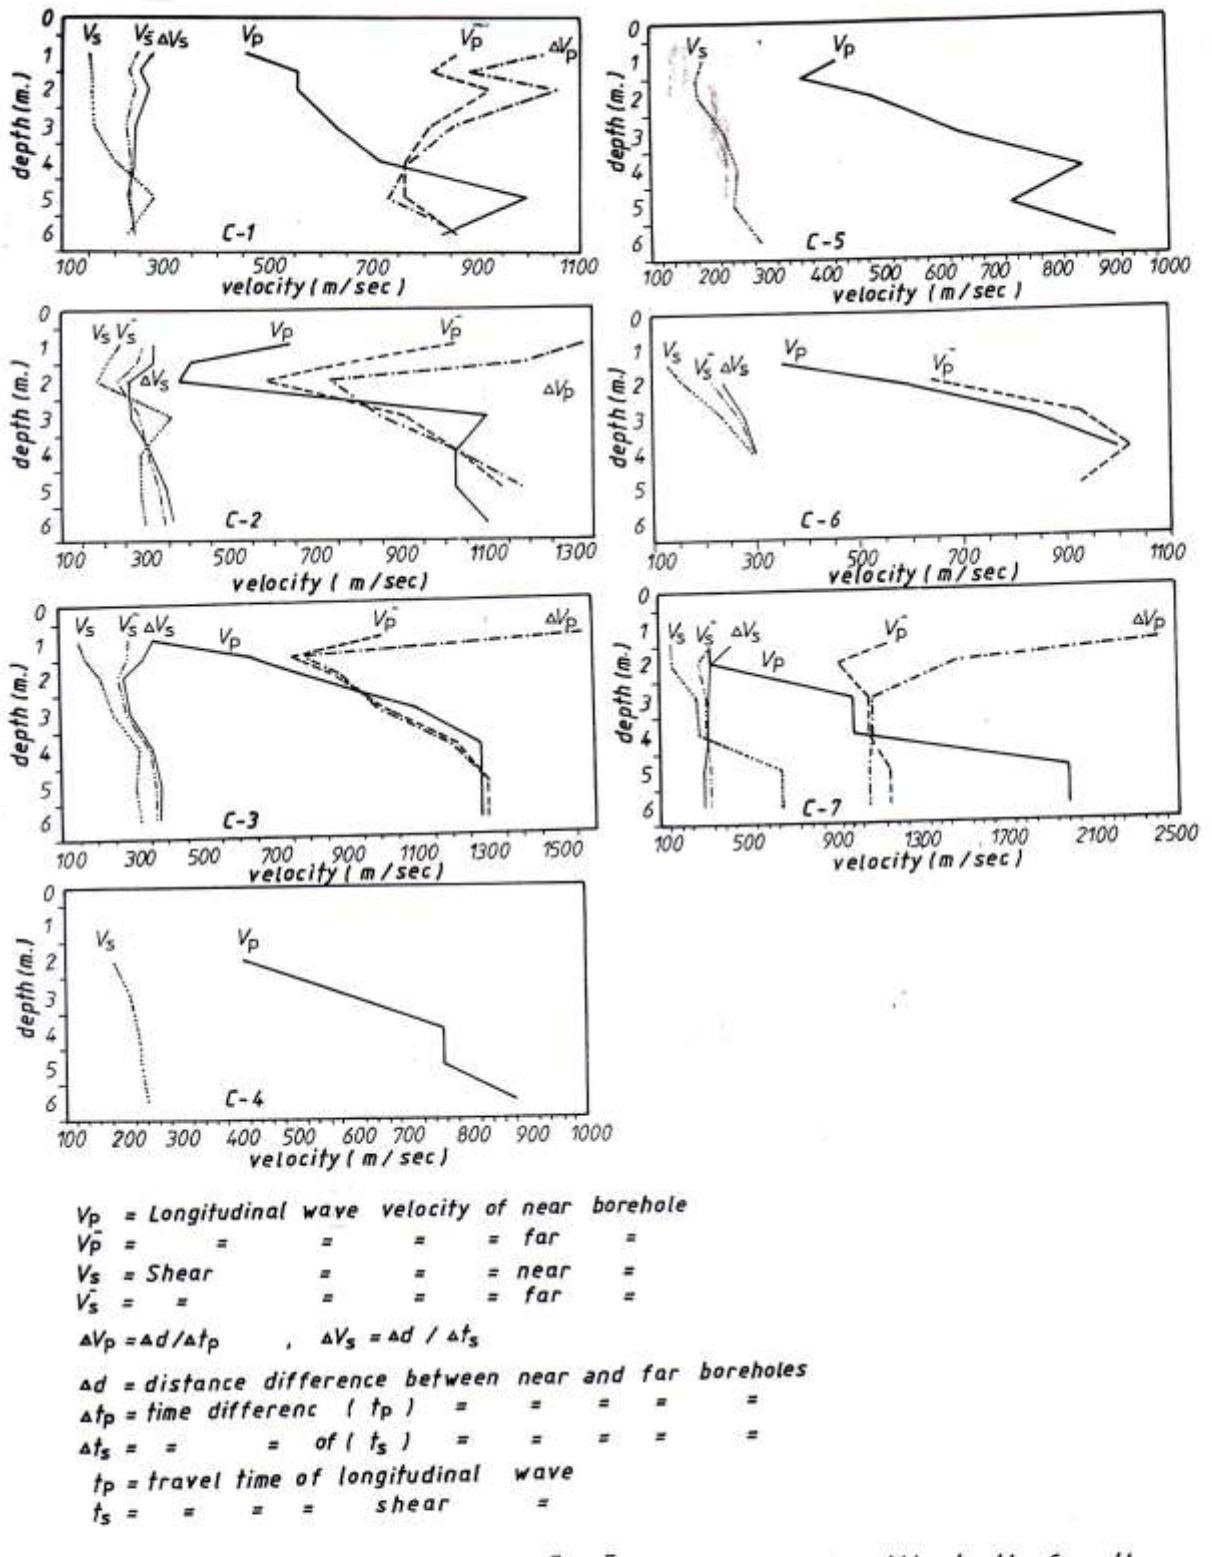
The mentioned velocities are determined for all cross-hole traverses except traverses 4 and 5, where only the Vp and Vs are applied. Velocity variation of longitudinal waves with depth in the boreholes is drawn to define the sharp changes related to the refractors, (figure 4). This figure show two abrupt changes in velocity, first change, at depth range 1.5-2.5 meters, is nearly coincide with the water table level and base of foundations. Second change observed at depth of 4 meters below the ground surface, (figure 4). The later refractor defined the top surface of the very dense sand layer.

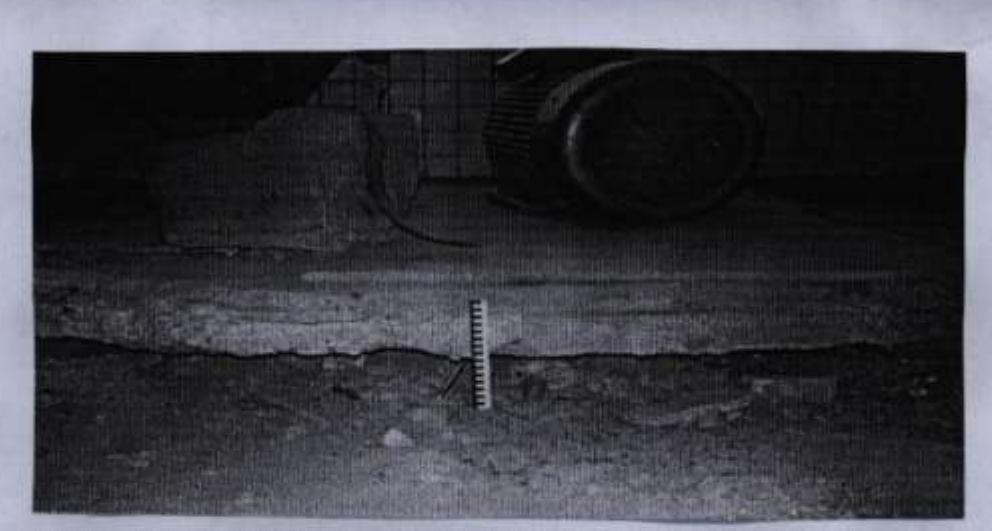
Plate -1- Cavity between the concrete floor and the soil in the high pumping station building.

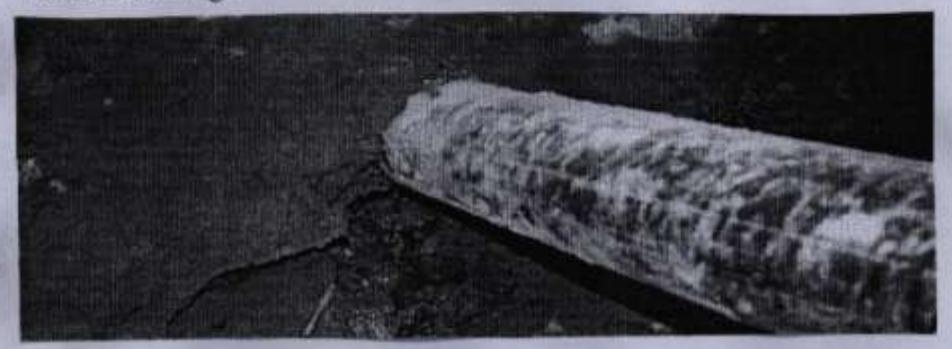
shallow refractor proves the change of water table level, from seven meters depth during the establishment of the project in 1972, to about two meters at the present time. It is believed that the causes of water table change may be related to the infiltration of water, from the broken pipes on the surface, to the soil.

Plate -2- A seepage below the pipe of water drain, where it is entering the pumping station building.

Depending upon the results of the study, it is strongly recommended to replace or repair the broken pipes to prevent water seepage in first stage. Secondly, in such case it is suitable to build up a monitoring system for the water level and composition, in order to define any probable external sources of water from the surrounding area.

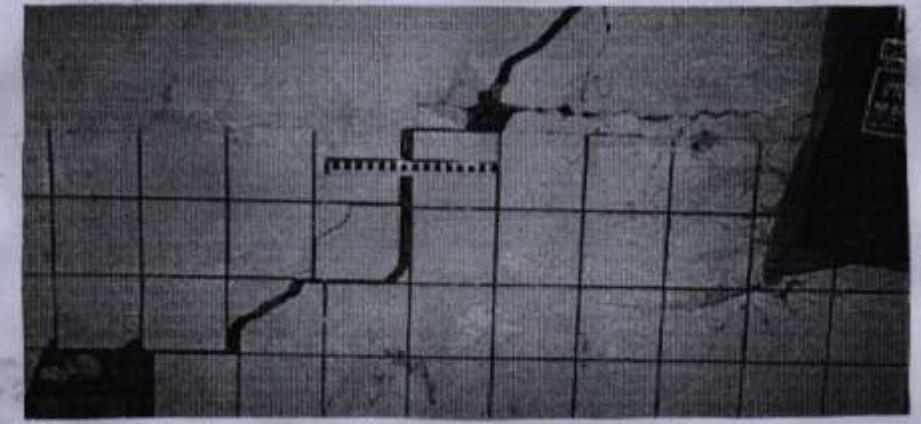
It is believed that water seepage from broken pipes and its infiltration through the soil play the great role in washing the soil and changing the water table level from one point to others. The differential washing of soil causes differential settlement beneath the buildings which is appears as cracks at the walls.

At the present time the potential surface (the water table) exerts a pressure that increases the strength of the soil against the loading force of the studied building. In the same time, the infiltration water, from the surface, weakens the soil through the process of gypsum washing. It is believed that, the differential response of soil particles, from place to another, to the washing process and continuous water table fluctuation causes the differential settlement and cracking in the walls of buildings and tanks.

Plate -3- Cracks in the wall of pumping station building.
