## Improving Fatigue Corrosion Resistance of Turbine Blades Using Laser Processing

Zaman A. Abdulwahab\*, Sami I. Jafar, Sami A. Ajeel

Production & Metallurgy Engineering Dept., University of Technology-Iraq, Alsina'a street, 10066 Baghdad, Iraq.

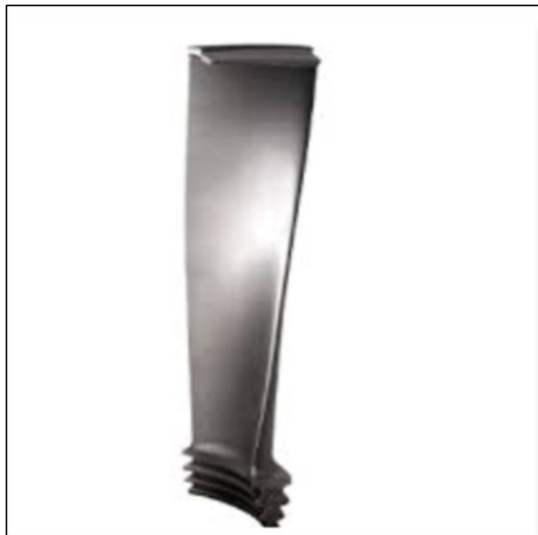
**Figure 1:** Steam turbine blades

Figure 1 shows the steam turbine blades from AL- Doura's station and Figure 2 shows the steam turbine blades after cutting; a portion of a steam turbine blade is cut into a 30 mm x 90 mm rectangle with a 2mm thickness for use in the electrochemical testing. With a Grinder and Polisher MoPao 160E. A rotating disk with abrasive materials ranging from 180, 320, 500, 800, 1000, and 2000 grits is used to grind the specimen material wished with water. These different degrees of grits are necessary to utilize SiC sheets with varying smoothness. Then, specimens are polished with alumina paste to obtain mirror surfaces. Nital solution (a mixture of 98 percent ethanol and 2 percent HNO<sub>3</sub>) is used for Etching turbine blade specimens. An air drier is used to dry the specimen after being submerged in the solution for around 15 seconds.

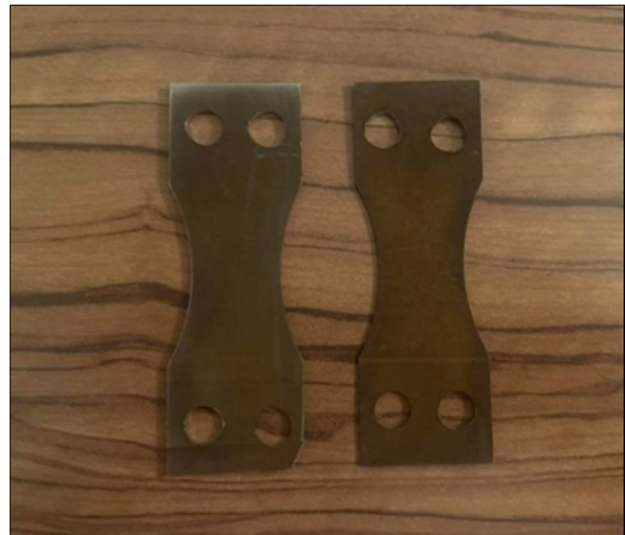
**Figure 2:** The St.52 blades of the steam turbine, after cutting

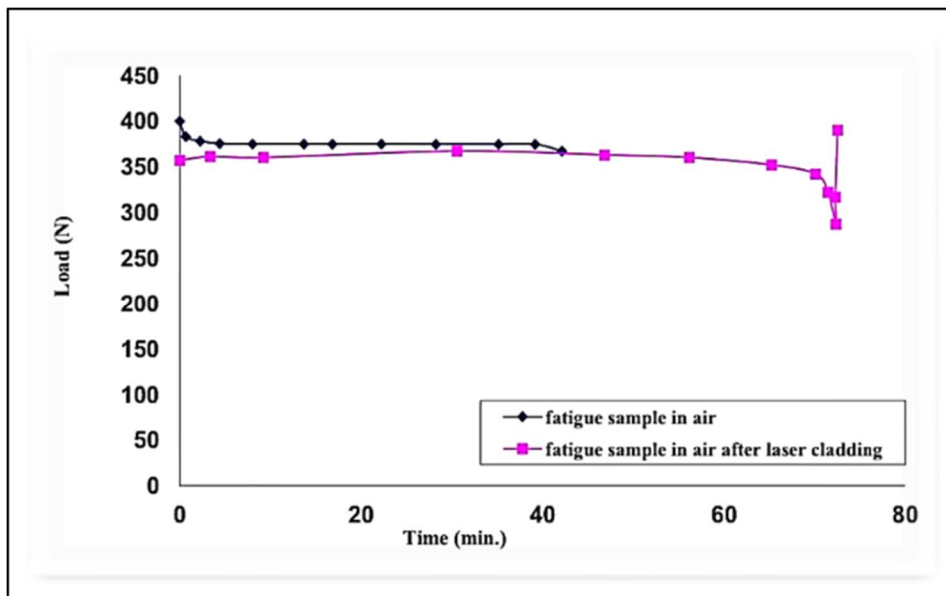
Figure 11: Fatigue specimen in the air and fatigue specimen after the laser cladding process

Figure 11 compares fatigue specimens in and after the laser cladding process. Figure 12 compares the fatigue specimen, the fatigue specimen in the air after the laser cladding process, and the fatigue corrosion specimen in solution to the laser cladding process. The fatigue limit (also called the endurance limit) is the stress level below which fatigue failure does not occur. This limit exists only for some ferrous (iron-based) and titanium alloys. Hence, the fatigue limit was high with many cycles [22].

It is clear from Figures 11 and 12 that there is little difference between fatigue specimens shot into the air before and after the cladding was applied by laser. However, the specimens' resistance to fatigue in the air was greater than that of the specimens in solution since the specimens in the air need more fatigue cycles and time before they fail.

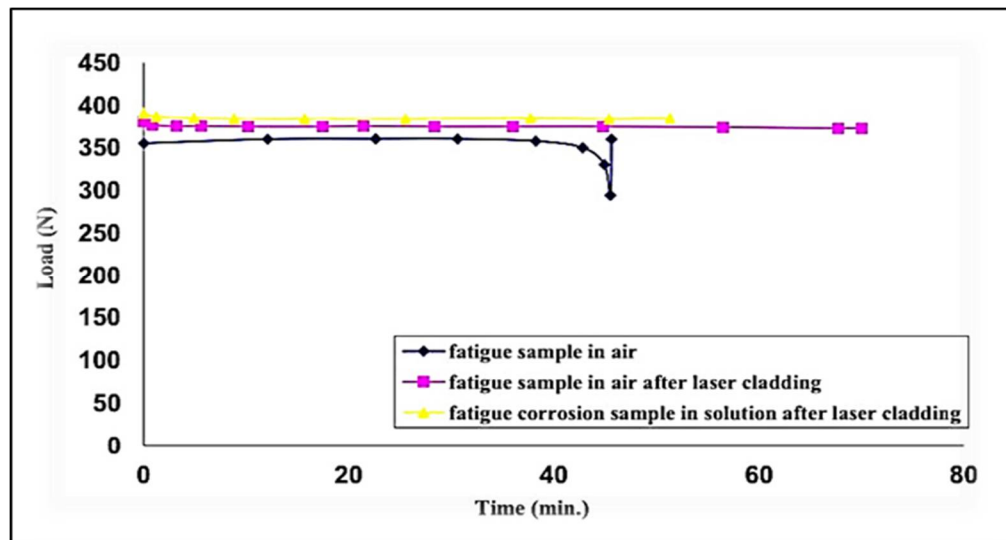
**Figure 12:** Fatigue specimen in the air, fatigue specimen in the air after the laser cladding process, and fatigue corrosion specimen in solution after the laser cladding process
