Reliability of Nondestructive Tests on Damage Assessment of Mosul Museum Building after Liberation Events

Civil Engineering Department, Collage of Engineering, University of Mosul, Mosul, Iraq

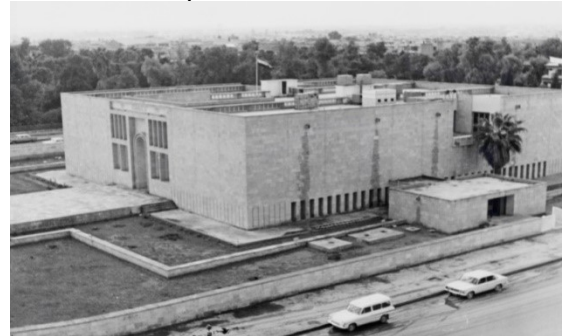
Mosul Museum was the second largest museum in Iraq after the National Museum of Iraq in Baghdad. The construction had started in 1969, and the building was opened in 1972. The super structure RC frame was constructed on an area of 1,620 m². Figure 1 shows Mosul Museum in early 1972. Figure 2 shows the plan view of the Museum. The basement consists of north entrance, conference hall, library, staff offices, art storage and lab. The ground floor is divided in to three main divisions, in addition to the reception lobby. The Mezzanine level is marked by

Fig. 1 Mosul Museum in 1972.

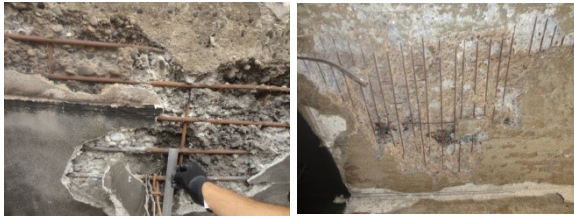
Fire at the basement floor: The library was burnt during the liberation of Mosul, June 2017. Burning this library was part of the master plan of setting a large part of the city of Mosul on fire. The zone surrounded between grids 'F' to 'L' intersects with grids '1' to '5' (Figure 2) was severely burned out. The fire damaged the concrete cover for slab

reinforcements, as shown in Figure 3. Some beams were severely affected by heat, and shear cracks were noted at several locations, as shown in Figure 4, (e.g. beams located along grid 'I' and between grids '2' to '4'). To check the concrete status at the core of the beam, a small chip of concrete was gently removed, as illustrated in Figure 5 and it was noted that the concrete color has been changed due to the heat.

Fig. 3 Damaged concrete cover for slab reinforcements in the library hall.

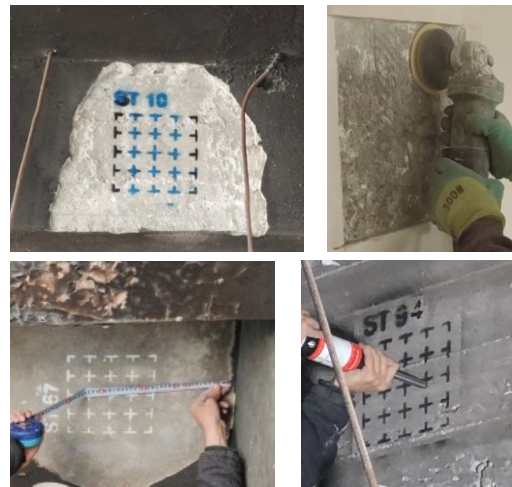
Schmidt Hammer Tests are used to assess concrete compressive strength. This test was performed on more than 100 different locations around the structure, footings, columns, beams, slabs etc. Before the test, each station is cleaned and the concrete face is smoothen with grinding machine and abrasive sandsheet, as illustrated in Figure 6. At each station, 16 sampling points were measured and tabulated. Then, the standard deviation was calculated, the deviations of individual sample readings showed minor deviations.

Fig. 6 Arrangements for hammer test at each station.

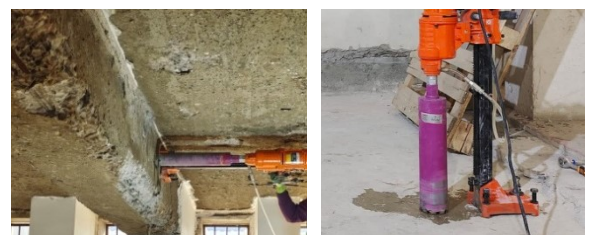
B, E and C, F were 75mm diameter cores collected from basement beam and column, respectively. Figure 10 shows the sampling of B and D cores. All the destructive core samples were done, satisfying ACI 214.4R [22] code requirements.

a) Core B at beam
b) Core D at slab
Fig. 10 Cores sampling.

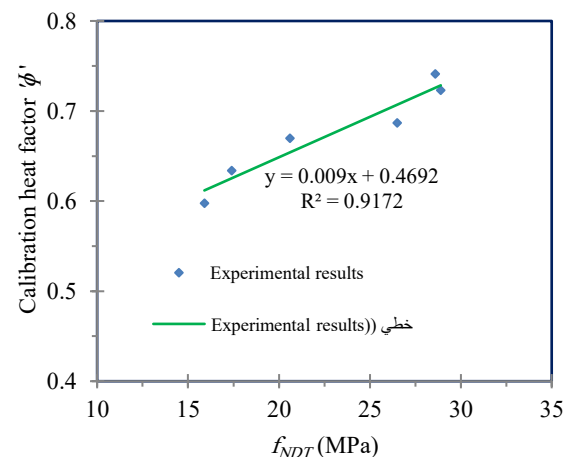
A statistical calibration heat factor for NDT strength test on a large number of NDT tests developed in the form of basic linear generic model was calibrated using Table 2 (destructive and nondestructive tests). Figure 11 shows the calibration of NDT test, depending on the strength degradation level by destructive core test.

Fig. 11 Calibration factor for NDT strength test.

Eq.(1) accounts for the heat factor depending on the destructive core test. While, Eq.(2) gives strength degradation for NDT calibrated empirical from destructive tests.

$$\phi = 0.009 \times f_{NDT} + 0.47 \quad \dots \text{Eq.(1)}$$

$$f_c = \phi \times f_{NDT} \quad \dots \text{Eq.(2)}$$

Where; ϕ is the heat calibration factor for NDT compressive strength degradation, f_{NDT} is the un-calibrated strength measured by NDT test. f_c calibrated strength for burned concrete elements. Table 3 shows the calibrated non-destructive (hammer) test results for the tested data (selected samples for the range tested data). The empirical Eq.(1) with a low root mean square error ($R^2=0.92$) means that the calibrated strength values are close to the real values.
