Tests of Composite Beams with Web Openings

Abstract

Keywords: Composite beam, web opening, moment to shear ratio.

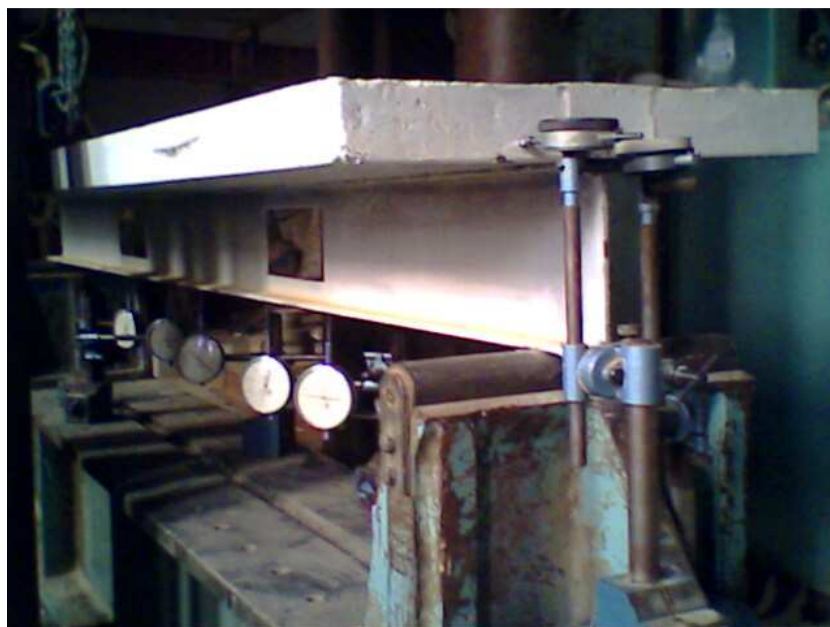
Figure (3): Typical Setting for Composite Beams before Testing

Prior to testing, the beams were painted with white color in order to provide a better surface for crack marking. Each tested beam was placed on simple supports at 5 cm from each end and loaded with a single concentrated load at midspan. Dial gauges of sensitivity 0.01 mm, were used to measure vertical deflection at midspan of the tested beam, and at the centerline and the two ends of each opening, Figure (3).

The beams were loaded with a single concentrated load at the center of the beam midspan, using hydraulic loading system with maximum capacity of 2000 kN. The load was distributed across the entire width of the concrete slab by a steel rod with a cross section of (25 x 25) mm which was placed on the top of the concrete slab at the load point.

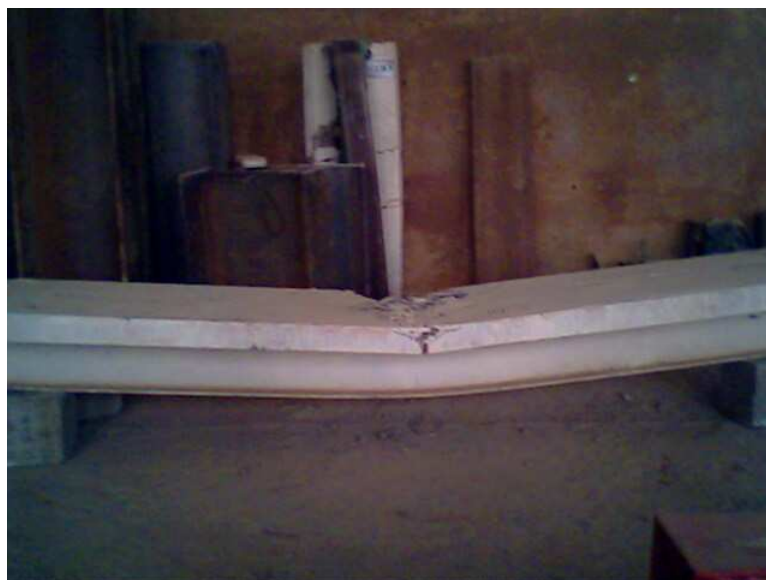
Figure (4): Beam CB0 at Failure

The test indicated linear load – deflection relation up to (64 %) of the ultimate load followed by ductile failure. At failure, excessive deflection occurred due to yielding of the steel beam at midspan which was followed, as a result, by crushing of concrete slab at center, Figure(4).The ultimate load was 124.6 kN.

load (P) (line load across the slab width) was applied in increments. As the load increased, to (105) kN, transverse cracks occurred at the center of the bottom face of the slab. The crack continued to widen as the load increased. A longitudinal crack at the center of the upper surface of the slab began to develop as the applied load had reached (120) kN (96 % of the ultimate load of the beam). The crack propagated towards the ends of the slab up to failure.

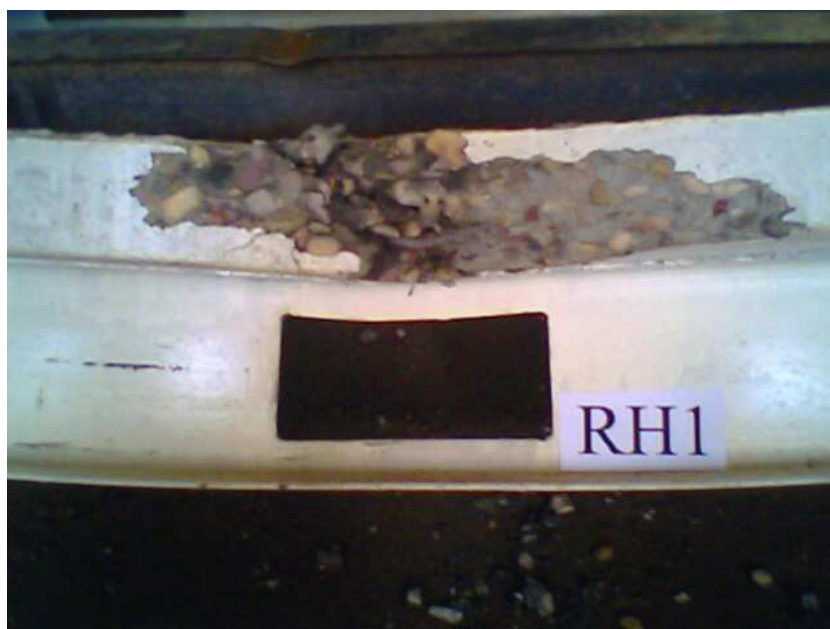
Figure (5): Opening RH1 of Beam CB1 at Failure

bottom tee of the web opening due to tensile stresses. The top tee yielding occurred due to compressive stresses after crushing of concrete slab at midspan which indicated the failure of the specimen. A close view for the opening RH1 at failure is shown in Figure (5).

Beam CB1 is constructed with one central rectangular opening RH1, 0.1 m depth and 0.2 m length. The cracking in the slab of this beam occurred when the applied load was (80) kN (83 % of the ultimate load). The initial crack of the concrete was transverse to the beam and at the center, where the M/V ratio is the highest. When the applied load was (90) kN, a longitudinal crack near the central section of the beam appeared and propagated longitudinally until failure. Initiation of longitudinal crack occurred at (93 %) of the ultimate load.

The load – deflection curve indicates linear relation up to first yielding of steel section, which took place after applying (80) kN (83 % of the failure load). However, yielding may have occurred firstly at the

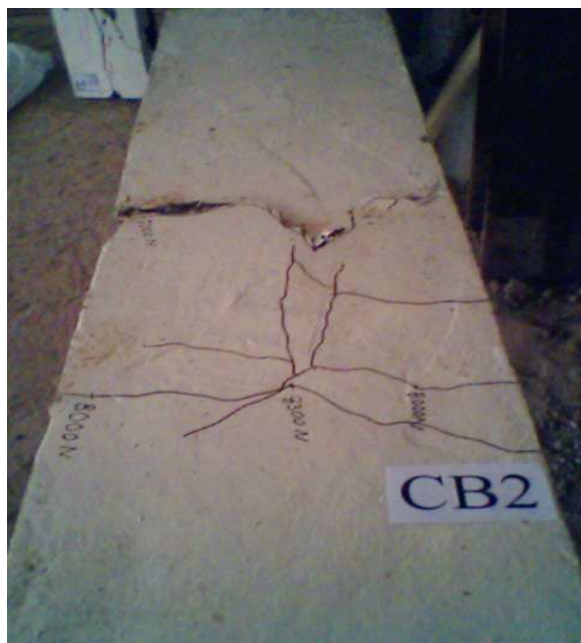
Figure (6): Cracking of concrete at Beam CB2

During loading, first cracking in the slab occurred at load level (65) kN (66 % of the ultimate load). The initial cracks of concrete slab were transverse to the beam near the low moment end of the hole. When the load was (80) kN (81 % of the failure load), a longitudinal crack at the top of slab and on the beam centerline, started from the high moment end of the opening and subsequently propagated towards the beam midspan. Transverse and longitudinal cracks are shown in Figure(6).

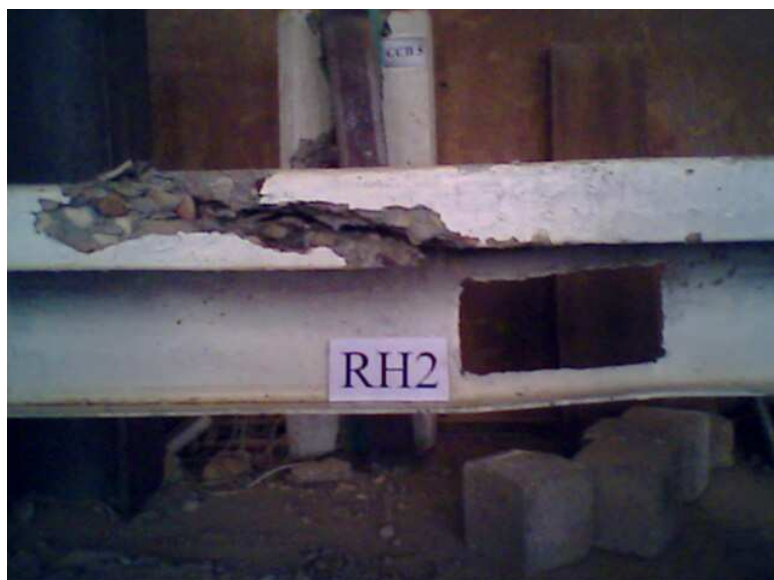
Figure (7): Diagonal Cracking at Hole RH2 of Beam CB2

The most significant cracking began at about (95 %) of the ultimate load, near the center of the openings RH2 on the bottom face of the slab. The slab separated slightly from the steel flange, and cracks propagated at about 45 degrees across the bottom surface of the slab, moving toward the high moment end of the opening. At failure, these cracks extended to the edge and propagated diagonally to the top of the slab, Figure (7). This shear type failure appeared to be due to the prying action caused by the large relative displacement between the two ends of the opening at this stage of loading.

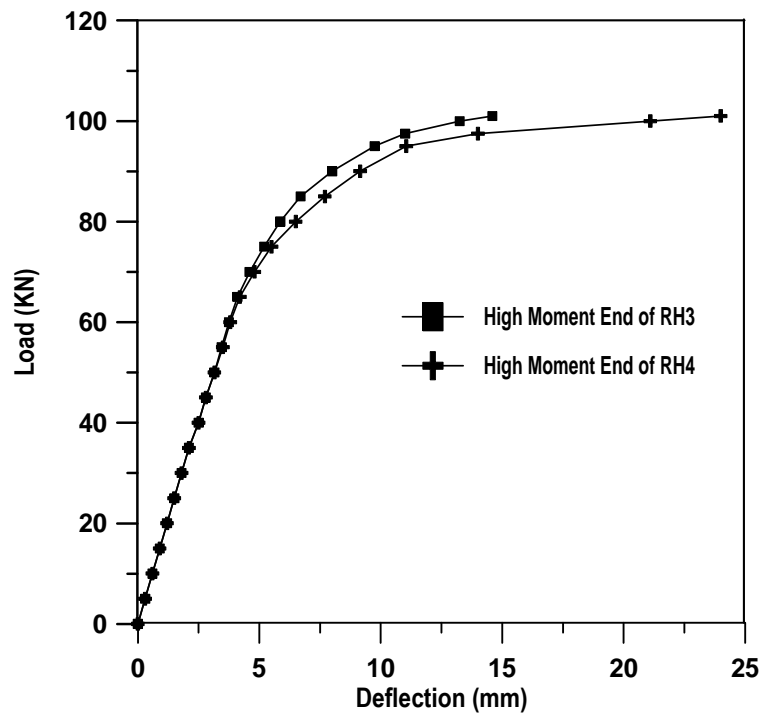
Figure (9): Deflection of High Moment Ends of Openings RH3 and RH4

the inclined crack and separation of concrete slab from steel beam had begun. Variation of deflection at the high moment ends of openings RH3 and RH4 during the test are plotted in Figure (9).

Due to the increase in the relative displacement between the two ends of the opening RH4 with increasing applied load, inclined cracks occurred at the slab near the high moment end of the opening. These cracks began from the bottom face of the slab and propagated toward the upper face. Loading was stopped when the relative deflection of the hole RH4 increased significantly which caused a clear widening in

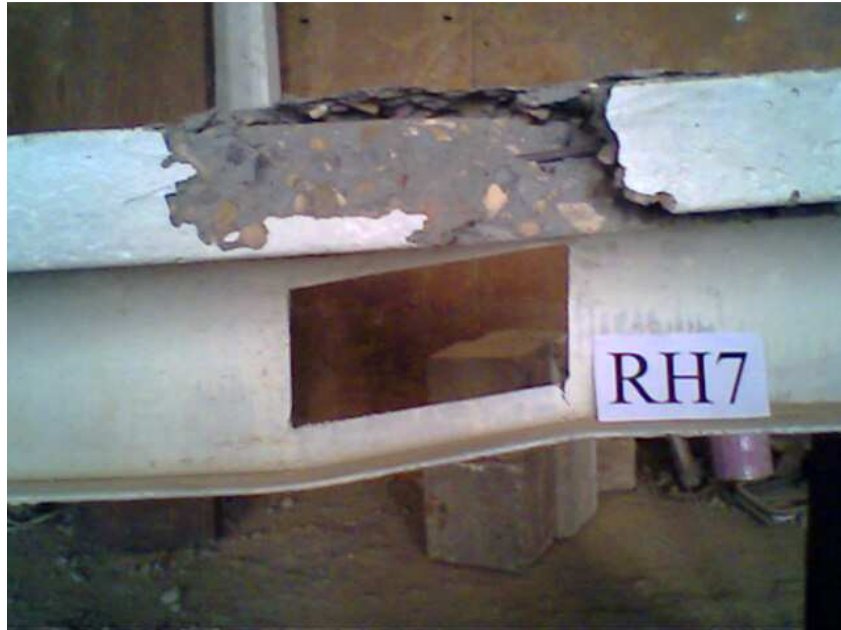
Figure (10): Failure at Opening RH7 of Beam CB4

With increasing load, a crack in the steel bottom tee near the low moment end of opening RH7 appeared at (85) kN. This was attributed to the concentration of tensile shear stresses at the opening corner. The crack softened the steel in the region and propagated excessively, that caused a rapid increase in the relative deflection between the hole ends. Due to this state of deformations, an inclined crack appeared at the bottom face of the slab over the low moment end of the hole. The crack propagated upward over the opening and appeared at the top face of the slab near the high moment end of the opening. Separation of concrete slab from steel beam began when the beam reached the ultimate load, 95.2 kN. Failure of opening RH7 is shown in Figure (10).
