Retrofit of Shear Critical R.C. Beams with Carbon Fiber Reinforced Polymers (CFRP)

Dr. Kaiss F. Sarsam* & Dr. Amer F. Izzet^{1b}

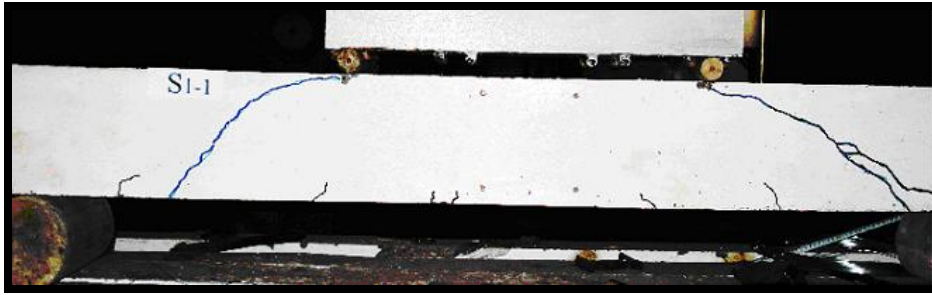
Figure 5: Beam specimen S1-1 as a control beam with steel stirrups (a/d=3)

Failure of the beam specimens tested in this investigation had different modes as presented in Table 5. Except for beam S1-8, all other beams showed no debonding (separation of CFRP strips or anchorage failure). In contrast, beam S1-8 showed visual separation due to debonding. Beam S1-8 (bonded by epoxy only) exhibited debonding similar to those indicated by other researchers [5.6.7] who relied on bonding alone. The specimen S1-1 failed in shear. Initially there were some flexural small cracks along the

beam bottom, when the beam reached approximately 50kN. The closest crack to the support (in the shear span at the left hand side of the beam) propagated directly towards the nearest loading point, (which is called diagonal shear crack). At the same time a diagonal shear crack formed in the middle of the shear span at the right hand side of the beam. With increasing load additional shear cracks formed throughout the shear span, widening and propagating until failure occurred because the right diagonal crack became very wide (the main shear crack) and reached the loading point at a total applied load of 100kN. Fig 5 shows the crack pattern of specimen S1-1 at ultimate load. In the control beam specimen S1-2 (without shear reinforcement), just one or two cracks were observed close to the middle of the shear span. When the applied load reached approximately 40kN, then with little increase of the applied load the single diagonal crack rapidly propagated and became wider. Then collapse happened by splitting the beam into two pieces along the main diagonal crack at a load of 50kN, Fig 6 shows the failure of the beam specimen. The differences between the failure of the beams with and without shear reinforcement were: The failure load was only slightly greater than the diagonal cracking load in the case of the beams without shear reinforcement S1-2. Also, there were only one or two diagonal cracks which caused the separation of the beam or by splitting the concrete around the main reinforcement near the support if the development length

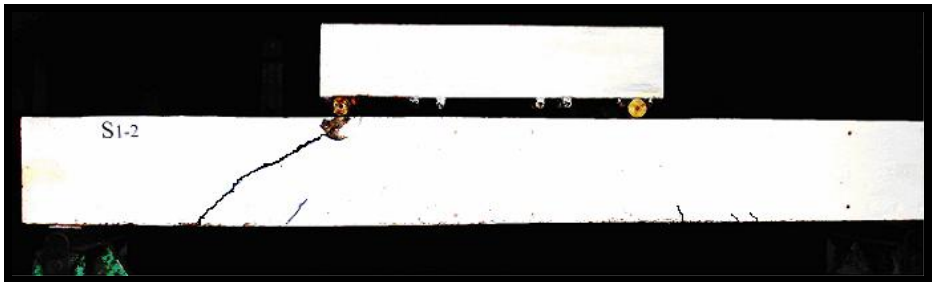
Figure 6: Beam specimen S1-2 as a control beam without steel stirrups (a/d=3)

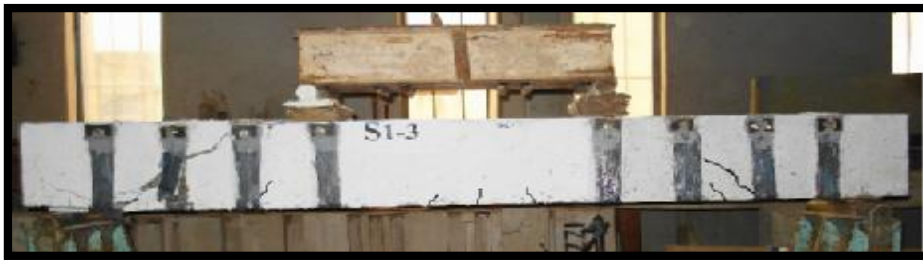
Figure 7: Crack pattern at ultimate failure of specimen S1-3

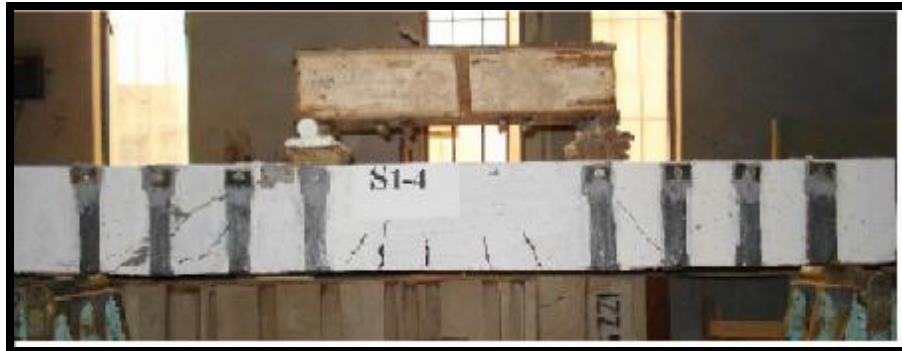
Figure 9: Crack pattern at ultimate failure of specimen S1-4

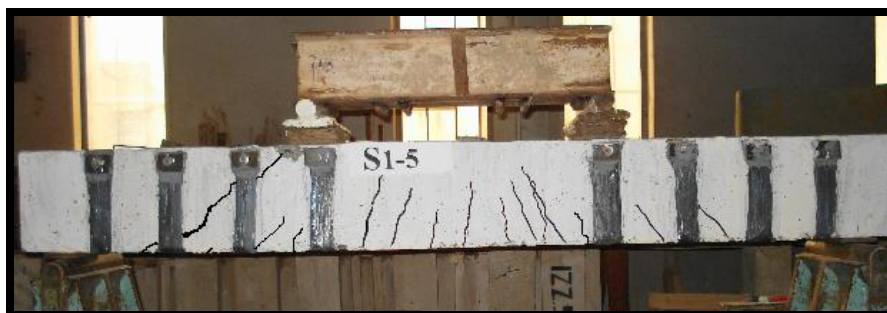
Figure 10: Crack pattern at ultimate failure of specimen S1-5

Beam specimen S1-5, the flexural cracks were observed first, and approximately when the applied load was 50kN a few diagonal cracks were observed. With increasing load the flexural cracks grew upward and became wider. At the same time the left diagonal crack propagated towards the loading point as shown

in Fig 10. At the applied load 110kN the diagonal crack rapidly propagated to the loading point and concrete under the loading point was crushed. As explained previously epoxy was used with end anchorage plates in this specimen to fix the CFRP strip but the left diagonal crack propagated toward the second CFRP strip at a level lower than that of specimen S1-4.

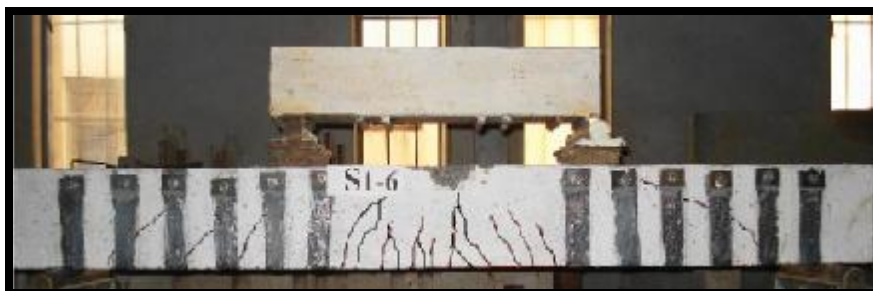
Figure 11: Crack pattern at ultimate failure of specimen S1-6

Beam specimen S1-6, where the spacing of the CFRP strips was decreased. The flexural behavior was observed more than the previous specimens. When the applied load reached 60kN many flexural and diagonal cracks were formed. With increasing applied load the right diagonal crack propagated. At the applied load of 135kN the failure happened after flexural cracks became wider and the shorter cracks formed near the bottom of the beam and extended towards the long cracks and joined them and propagated towards the compression zone. Finally, the concrete crushed at some point between the two loading points. Fig 11 shows the crack pattern at failure. Beam specimen S1-7, with increasing the amount of CFRP (three layers) and decreasing CFRP spacing (same spacing as S1-6), the flexural behavior was very clear by reaching the ultimate flexural capacity. This did not prevent some diagonal cracks to appear in the shear span at a load about 60kN. The flexural cracks in the middle zone when the load reached 100kN extended upwards and continued in widening then joined other cracks. When the load reached 140kN some of the flexural cracks became wider

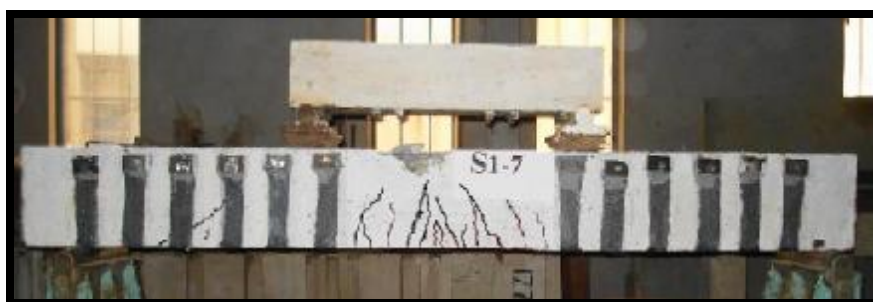
Figure 12: Crack pattern at ultimate failure of specimen S1-7

than the others between the two loading points and propagated upwards causing concrete crushing without reaching the diagonal shear crack to the loading point, as shown in Fig 12 . Beam specimen S1-8, as the applied load increased the deformation of the specimen obviously increased. This broke the bonding between the CFRP strips and the concrete cover (thin layer of epoxy type Sikadour330) and the sound of the separation (destroying the epoxy layer) was very obvious. At about 40kN diagonal shear cracks formed, growing and propagating until failure occurred immediately after separation of the CFRP strip then the diagonal crack reached the loading point as shown in Fig 13 and the beam separated into two pieces at a total applied load of 60kN. The failure was sudden and explosive after the separation of the second CFRP strips at each side of the specimen. There were some attached particles of cement on the separated CFRP strips.
