Behavior of Prestressed Concrete Non-Prismatic Double Tee Beams

د. حسام علي محمد
الكلية التقنية-المسيب

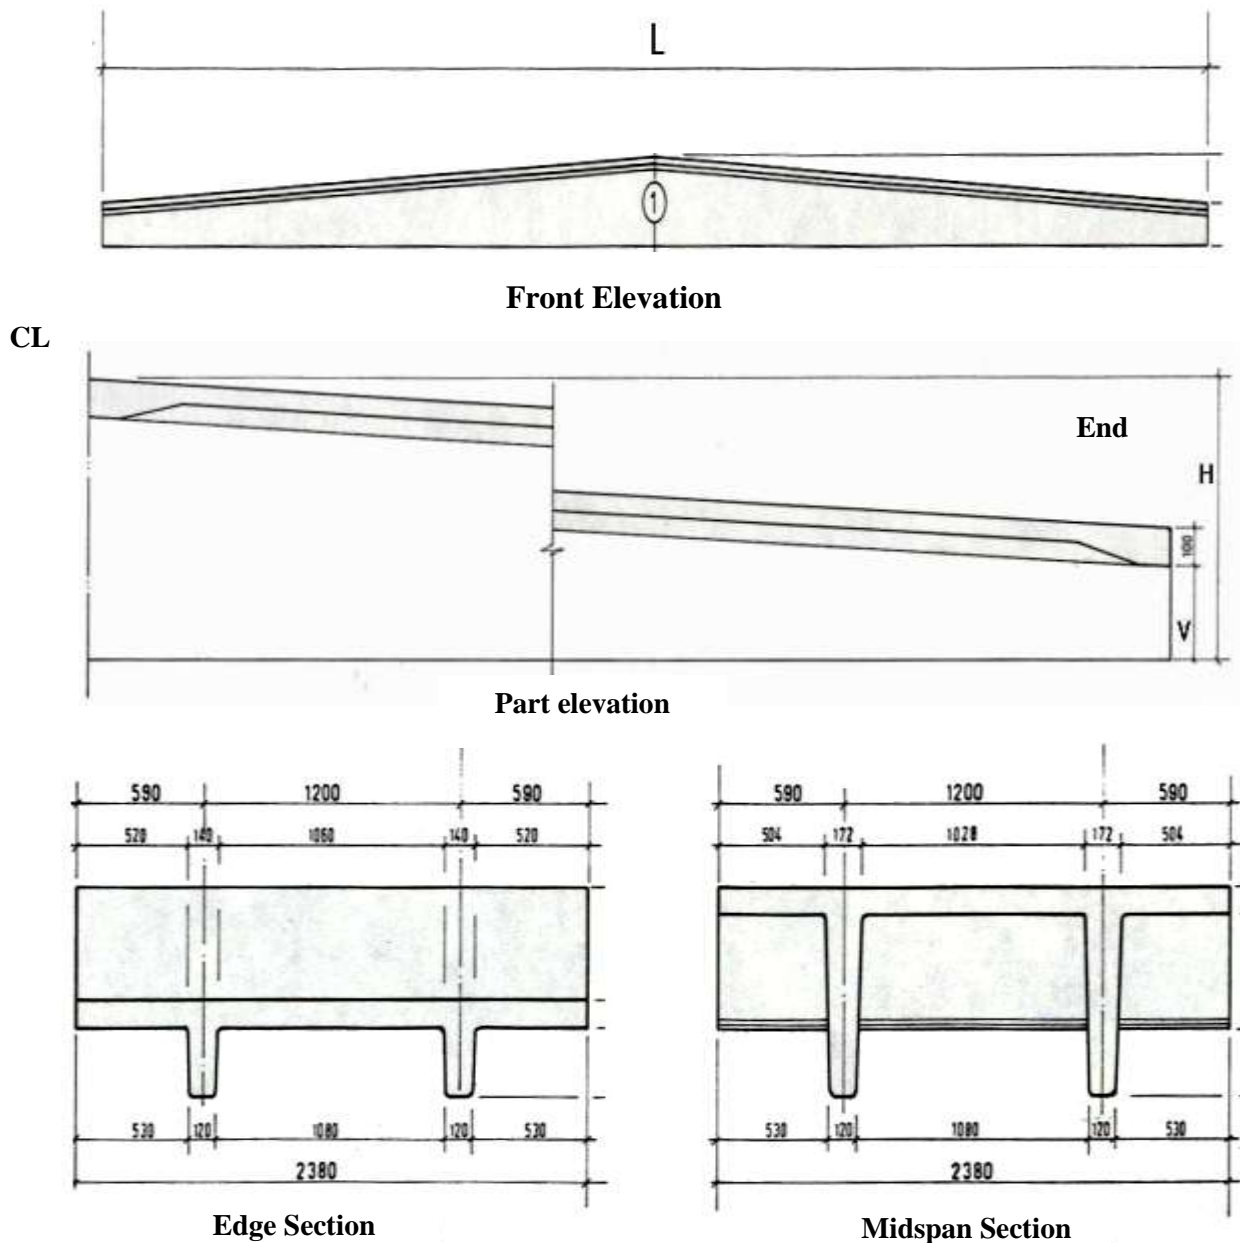
Fig. (1). General shape of the chosen double tee beams

The present experimental program was conducted at the laboratories of Al-Rasheed State Company for Constructional Contracts. The specimens chosen to be tested experimentally were typical production full scale double tees having total length of 13, 18, and 20.7m, representing similar units used in practice as roofing. The double tee beams examined in this study were 425, 550, and 482.5 mm deep over the support and 750, 1000, and 1000 mm deep at mid span respectively. The beams had web width of 120 mm and flange width of 2380 mm. For all of these beams, the slope of descend of top surface is 1/20. General elevation and beam cross-section are shown in Fig. (1) [2].

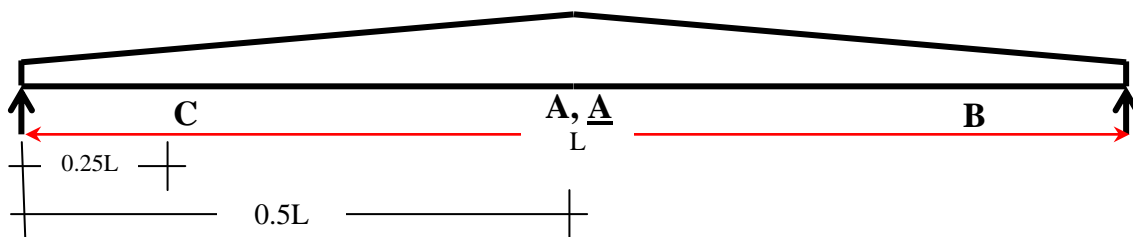
Fig. (3). Typical dial gages instillation.

Prior to the test, the beams were instrumented with four dial gages to measure vertical displacements. Gages were installed at beam midspan (gages A and \underline{A}) and 0.25Lm far from each support (gages B and C). The dial gages used had 25 mm stroke and 0.025mm accuracy. For beam B2 and B3, the gages being inefficient to continue the test up to failure, so alternative measuring by means of a theodolite and a vertical ruler coupled with an indicator were used.

During each test, the displacements were measured at two positions "close to supports and quarter span" for the tested beam. Fig (3) shows a typical dial gage installation.

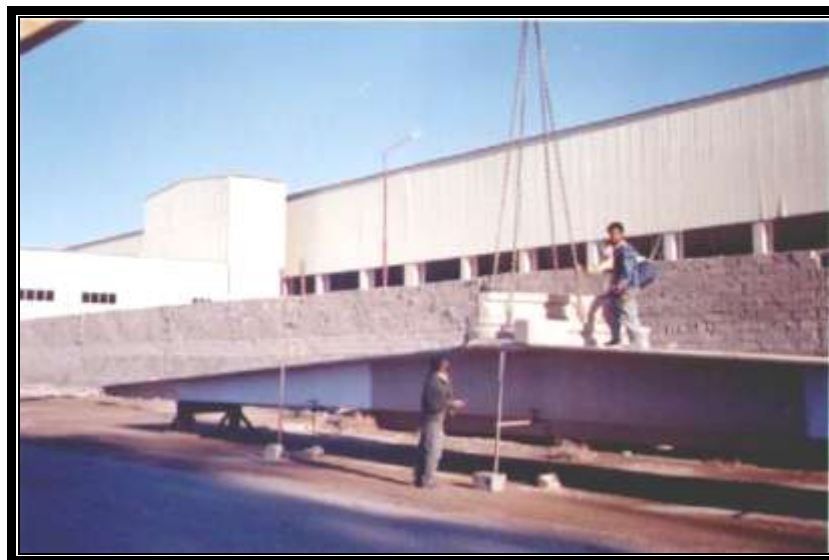
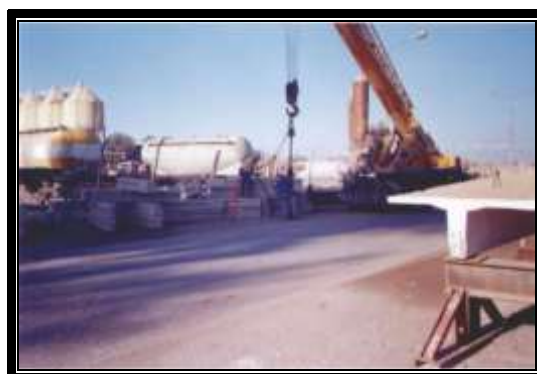
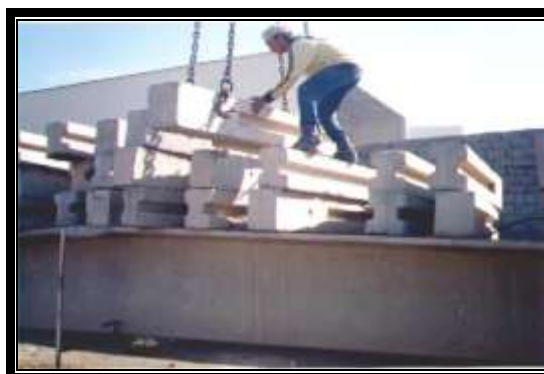
Fig. (4) General test setup for the tested non-prismatic beams [3]

Non-prismatic double tee beams are widely used in roof applications, on that base, the loading arrangement was chosen to be uniformly distributed loads. For beam B1, the loads were distributed along its span length, while for the case of beam B2 and B3; the loading was uniformly distributed along the central part of the length span, to increase the bending failure probability. Figure (4) shows the loading process and test setup.

All beams were subjected to uniformly distributed load along the span length. Large concrete blocks measuring $0.3 \times 0.25 \times 2.4$ m and weighting 4.20kN each, were used to simulate the quasi-uniform loading condition.

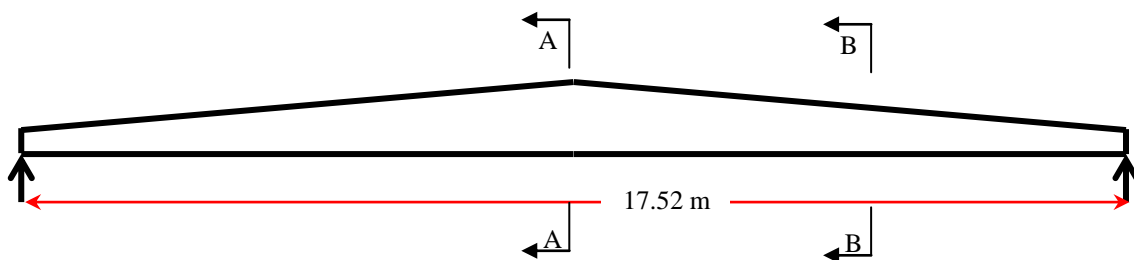
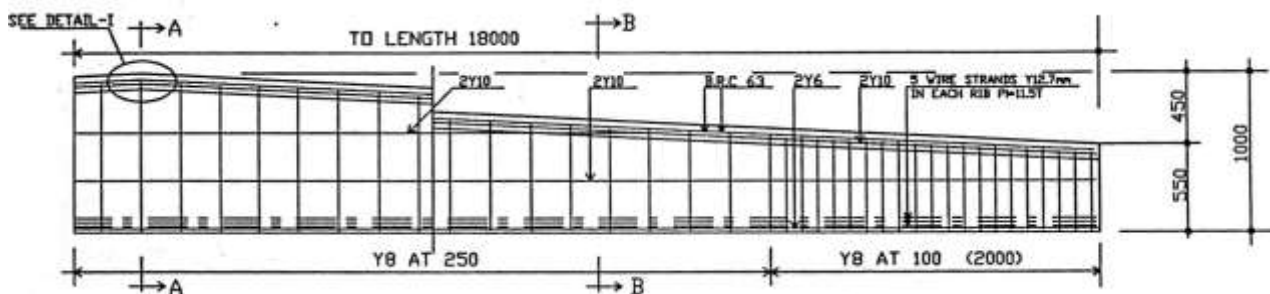
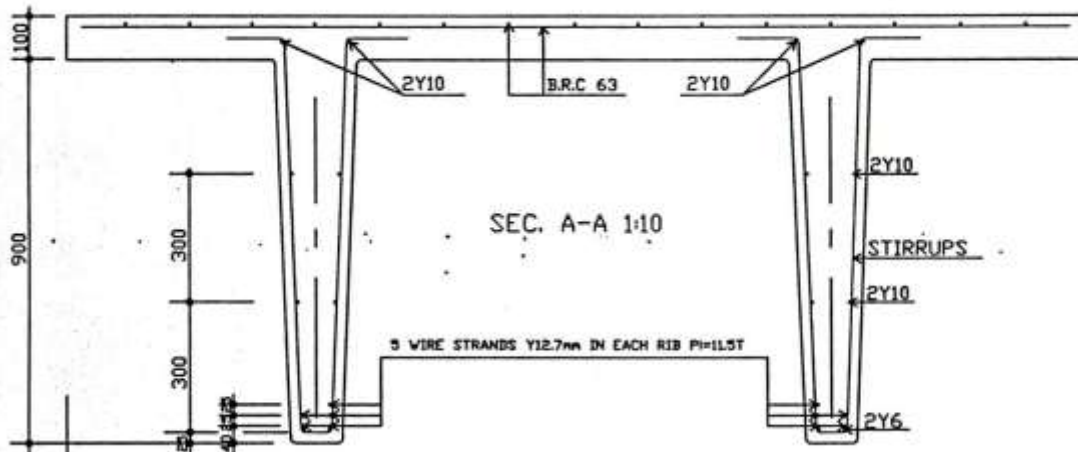
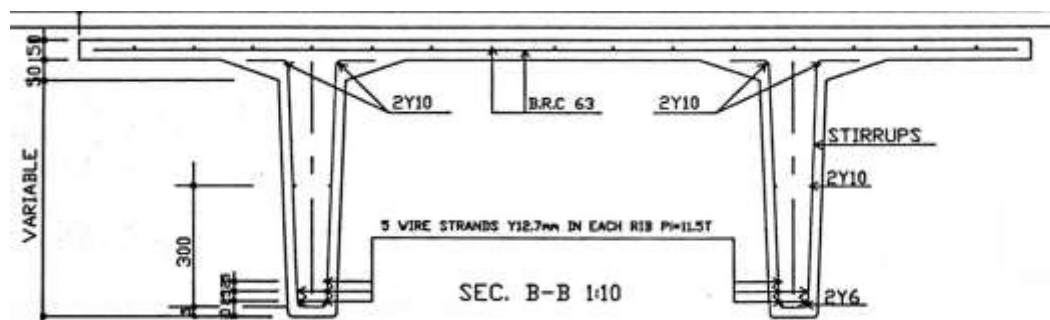
Fig. (5). Beam B1 – Elevation and Section Properties [3]

The test specimen was a 2380 mm wide beam, 550mm deep at the support and 1000mm at midspan. The double tee cast with normal weight concrete and was designed for a fully precast roofing structure application. The member length was 18m for which the flange was 60mm thick and cast monolithically with the legs. The nominal concrete strength at 28days was 40MPa, which is commonly used in the plant's concrete marketing area. The design service load was 2.8 kN/m^2 . Section properties are shown in Fig. (5) and listed in Table (2).

The specimen contained ten wire strands 12.7mm in diameter, Grade 270, low relaxation initially stressed to 115kN. The legs of the double tee contained eight mild steel 10mm in diameter, with vertical stirrups 6mm in diameter with equal spacing of 250mm along the leg. The flange was reinforced with welded mesh fabric. The beam was tested under service loading condition to check its compliance to the ACI code acceptance requirements regarding deflection and deflection recovery.

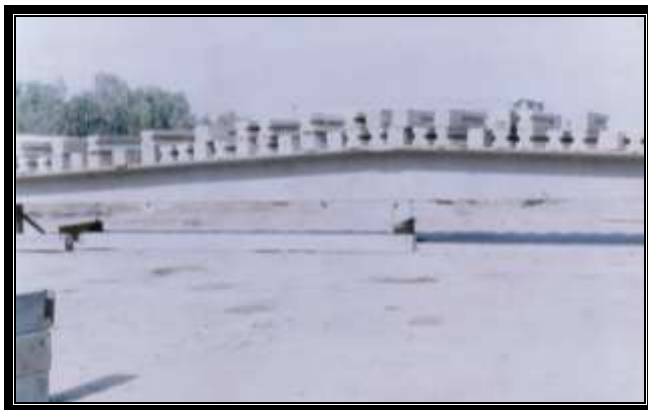
Fig. (8). beam B1 – Arrangement of the total uniformly distributed loads.

The test was performed over a four-day overall period in accordance with Chapter 20 of the ACI 318-02 Building Code [1]. A 3.75kN/m^2 uniformly distributed load was applied along the beam top surface, without causing any shock on the beam. This load represented the superimposed dead load, as shown in Fig. (6). The specimen left with this load for 48 hours without any external effect. Later the dial gages were installed and some notes were recorded on the beam behavior, as shown in Fig. (7). Then, the beam was loaded with additional uniformly distributed test load of 2.8kN/m^2 which represented the live load as in Fig. (8). The loading procedure was applied in four stages. At each stage, the deflection was read and notes were recorded. The specimen again was left for 48 hours under this loading condition, and the overall deflection was recorded. After that, the testing load 2.8 kN/m^2 was released, and the beam left for 24 hours to get the final deflection recovery.

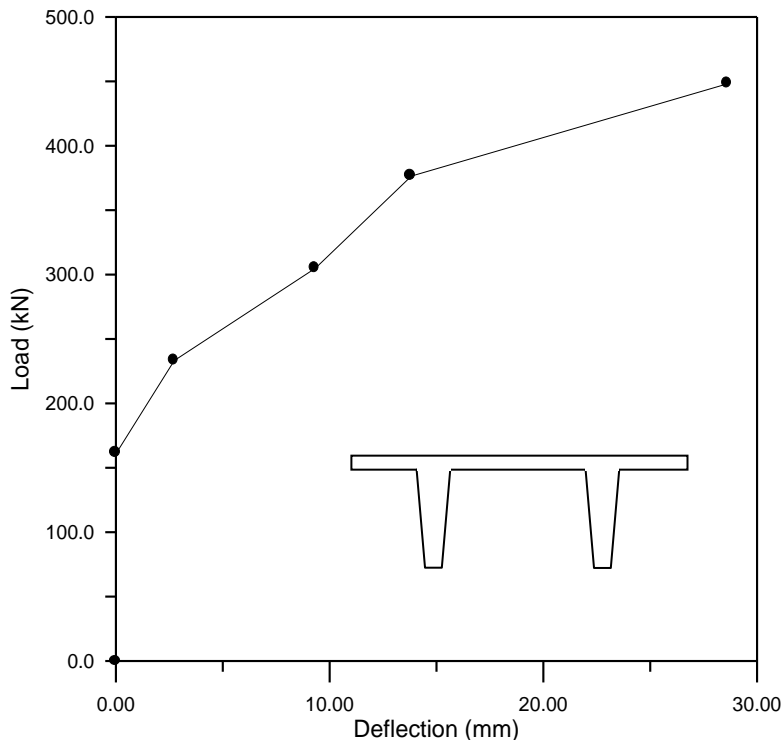
Fig. (9).Beam B1 –Total load- Midspan deflection response.

where L_t is the beam test span length and h is the beam height. If the maximum deflection exceeds this value, deflection recovery within 24 hours after test load removal shall be greater than 80% of the total deflection. Hence, deflection reading recorded during the test provided the basis for acceptance of the double tee beams. Because vertical deflections at midspan exceeded maximum deflection stated into Eq. (3.1) above as indicated in Table (3.3) in Gage A, and A (28.6 and 29.9mm respectively), it was necessary to take the deflection recovery in consideration. After the test load was left in position for 24 hours, deflection readings were recorded and the test load was removed. The recovery deflection was 6.2mm and 5.9mm at gages A, and A, respectively, as shown in Table (3.3). For both gages, the reading deflection recovery was less than the value indicated by Eq. (3.2) for test load sustained over 24 hour time period. Figure (3.9) shows the load-deflection curve obtained for this beam.

Since the required deflection recovery was realized immediately following test load removal, further load testing was discontinued. In terms of ACI structural strength requirements, the tested double tee beam performed satisfactorily.

Deflections obtained at midspan and at regions close to support are summarized in Table (3). Besides recording the deflections, the double tee beams were visually monitored for distress throughout the load test. Application of the superimposed dead load and the first stage of the test resulted small horizontal non-structural hair crack the junction of web and in flange intersection, and on the web at regions close to the support. These cracks stay in their form without propagation during the loading progress. During application of the next loading increments, flexural hair cracks were observed at midspan.

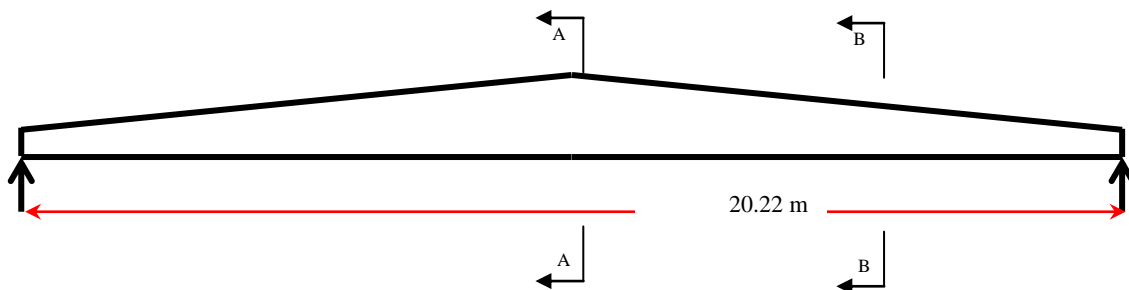
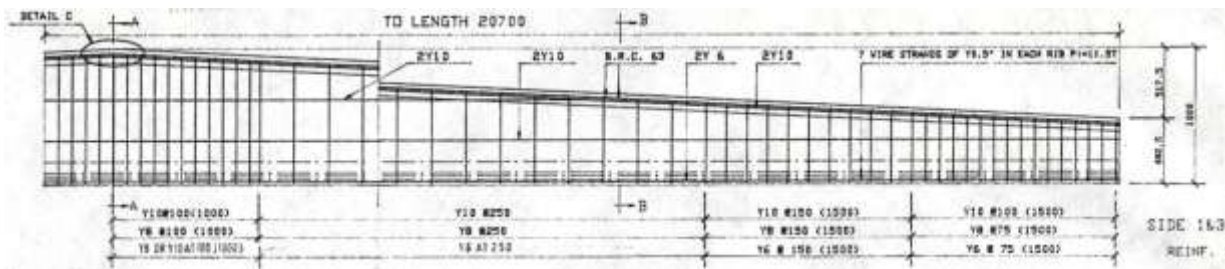
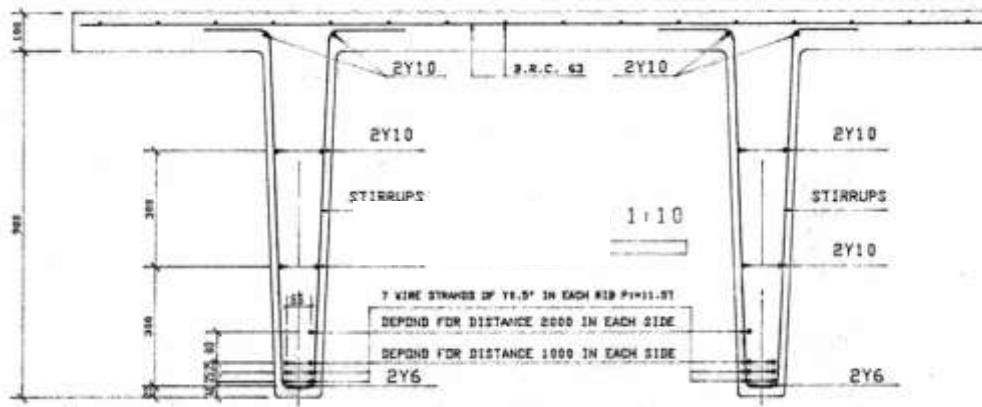
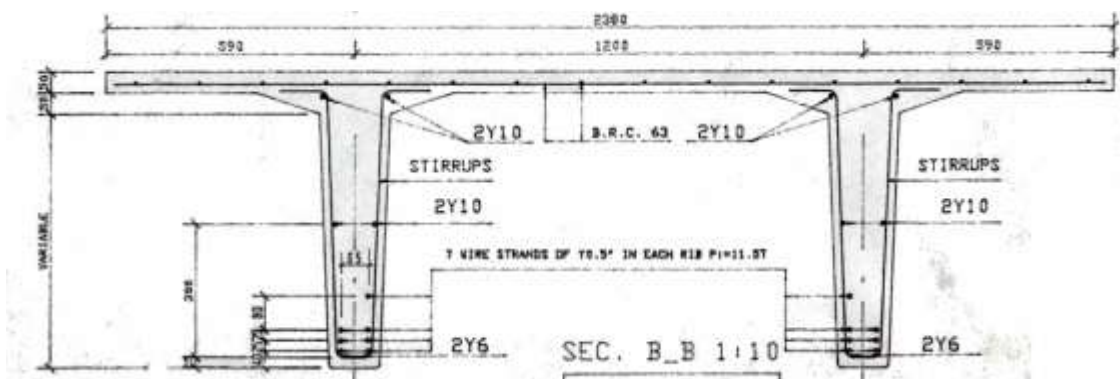
Fig. (10). Beam B2 - Elevation and Section Properties.

The tested beam B2 was identical in cross sectional dimensions with beam B1. Depth of the beam was 1000mm at mid-span and 482.5mm at supports. Total beam length was 20.7m retaining the same descend slope of 1/20. This beam was drawn from a number of stored units with the mentioned dimensions and it was designed for a fully precast roofing application. This sample was supported by an I-section of 250mm flange width. The flange thickness of the beam was 60 mm monolithically cast with the legs. The nominal concrete strength at 28days was 45MPa, which is commonly used in the plant’s marketing area. Section properties are given in Fig. (10) and listed in Table (4) [3].

The specimen contained fourteen wire strands 12.7mm in diameter, Grade 270, low relaxation initially stressed to 115kN arranged equally per ribs. The legs of the double tee contained twelve mild steel bars (eight of them was of 10mm and four of 6mm in diameter), with vertical stirrups 6mm in diameter divided equally along the leg. The flange was reinforced with welded mesh fabric. This time, testing of the beam was continued up to failure.

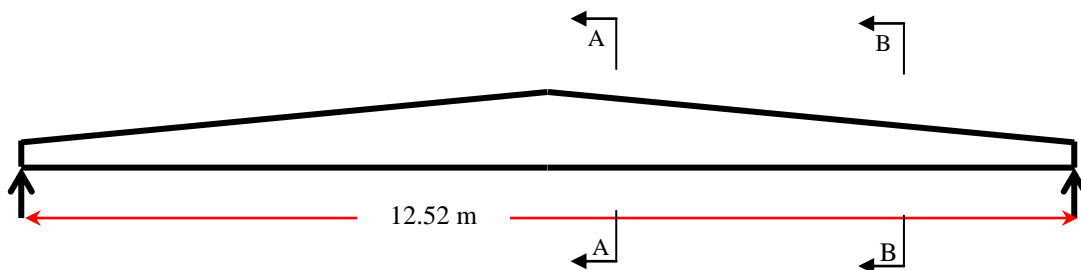
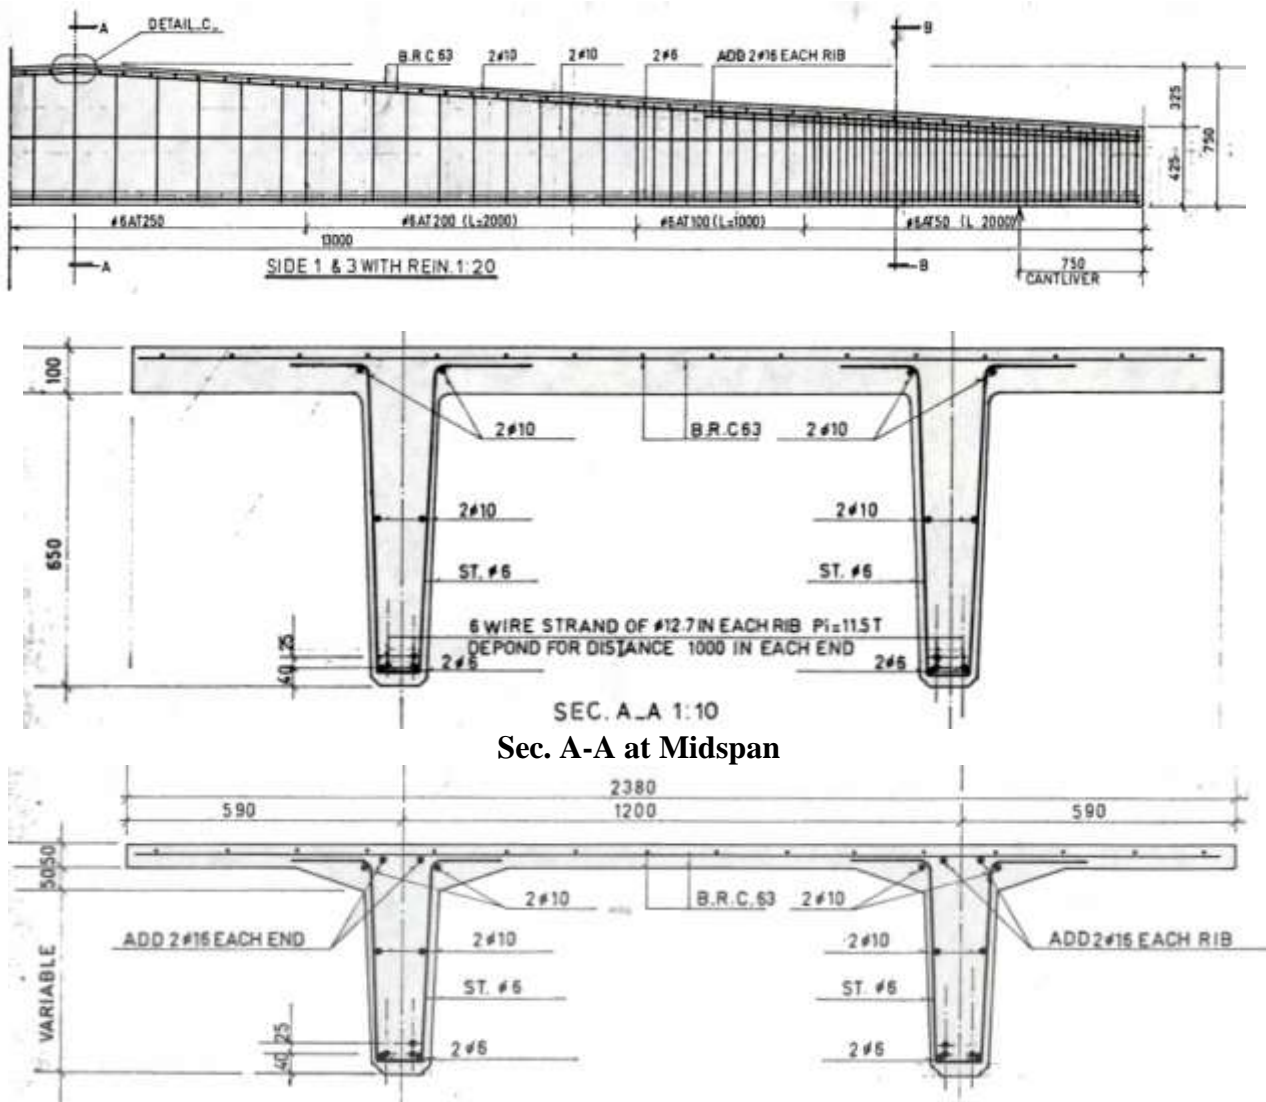
Sec. A-A at Midspan
Sec. B-B General Section.
 (All dimensions not indicated are in mm)
Fig. (18). Beam B3 - section Properties [2]

The test specimen consisted of 2380mm wide flange. Depth of the cross section was 425mm at supports and 750mm at midspan. The beam cast with normal weight concrete and was designed for a fully precast roofing structure application. The member length was 13m. The flange was 60mm thick and cast monolithically with the legs. The nominal cube concrete compressive strength at 28days was 41kN/m². Section properties are given in Fig. (18) and listed in Table (4). Figures (19) and (20) show the test procedure [2].

The specimen contained six wire strand 12.7mm in diameter, Grade 270, low relaxation initially stressed to 115kN arranged equally per ribs. The legs of the double tee contained twelve mild steel (eight of 10mm and four of 6mm in diameter bars), with vertical stirrups 6mm in diameter divided equally per leg. The flange was reinforced with welded mesh fabric B.R.C 63. The beam has been tested up to failure.

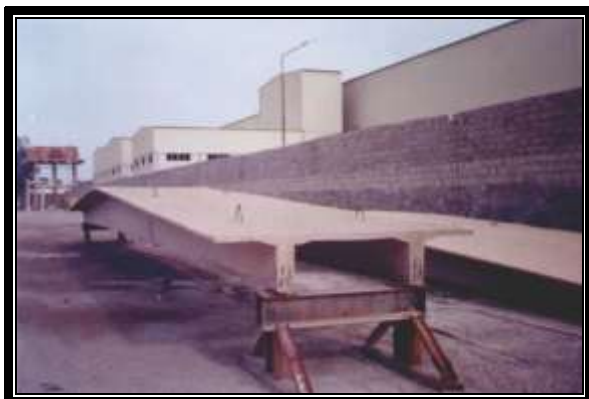
Fig. (11). Beam B2 – General view before testing.

The test was performed over a two-day period. The beam was subjected to a progressive increasing load while deflections at each increment of loading were recorded by applying a single or a couple of loading blocks. The loading was applied to the middle part of the beam ending 5.5 m away from the supports as shown in Figs. (11 to 14). This was a measure to increase likelihood of bending failure.

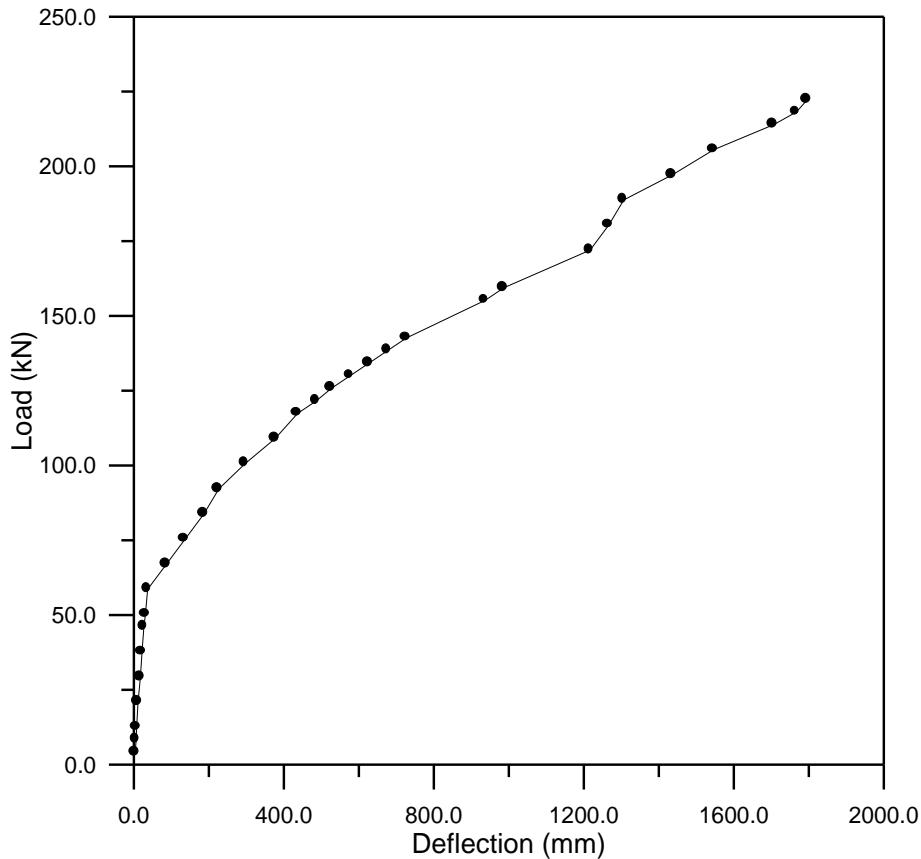
Fig. (15). Beam B2 – Total load- Midspan deflection response.

Displacements were measured at both ends and at the center of the span for the tested beam throughout the entire range of loading. Figure (15) shows the deflection progress with increasing the applied load recorded using the midspan dial gages and measurement instruments.

Clearly shown from Fig. (15) that the stage of elastic behavior has been terminated at the first cracking load which equals to 68kN, which represent 30% of ultimate carrying load that equals to 222kN. The stage followed the cracking load was accompanied with crack propagation which increase in width as the applied load is increased. The failure finally occurs at a distance equal to 26% from the total beam length measured from the support.

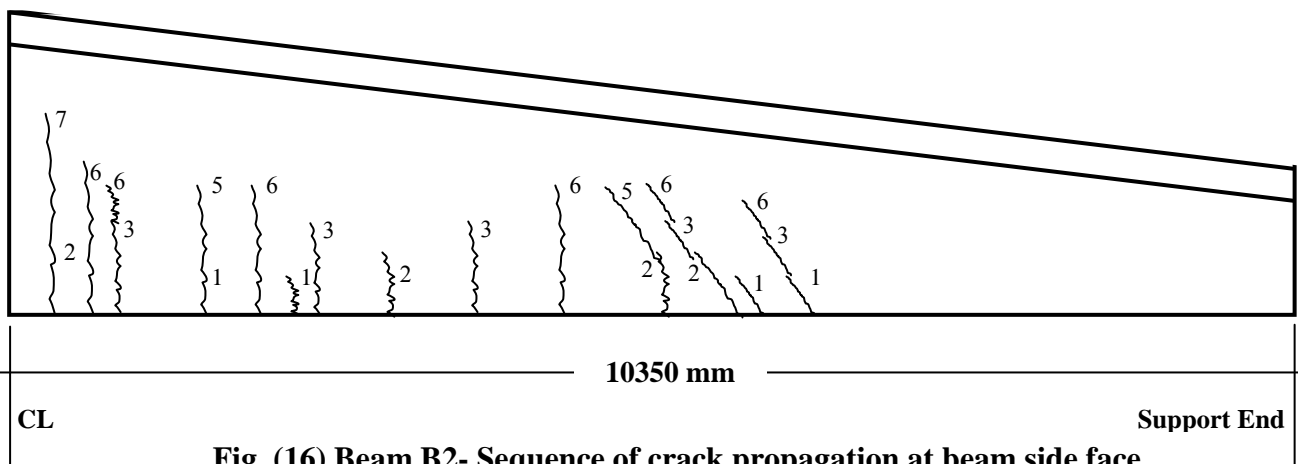
Fig. (16) Beam B2- Sequence of crack propagation at beam side face.

Flexural cracks were observed first at midspan. These cracks initiated at beam bottom face and propagated upward with increasing load. The flexural cracks become wider and wider until flexural failure. All cracks that appeared were recorded. The using of small steps of loading (by applying blocks at relatively small increments) has a significant effect on reading the deflection and monitoring the cracks. Each crack was indicated with a number equals to the stage of loading. In the same way, the development of that crack was re-indicated. Figure (16) and (17) represents the sequence of crack propagation.

According to the crack propagation, the applied loads were divided into seven increments relatively to crack developments. Figure (16) draw on that base, where the crack indicated according to the loading increment set close to it, with the inclination recorded in test time.

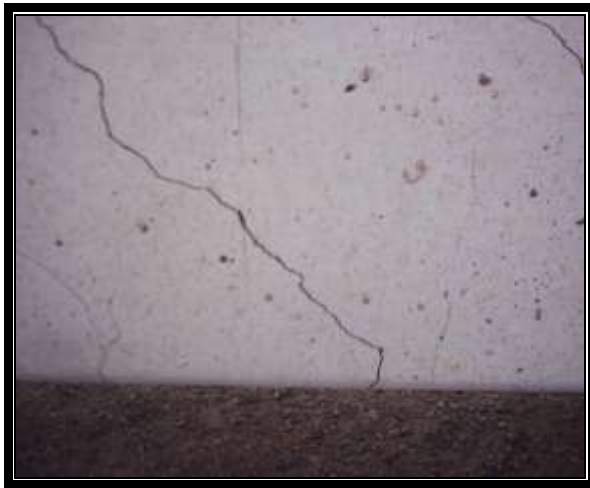
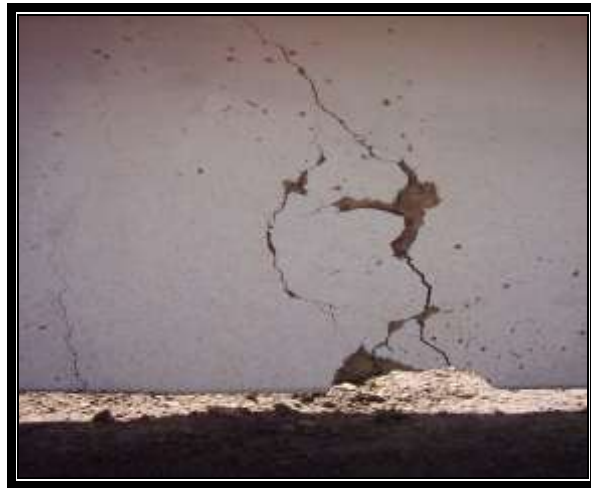
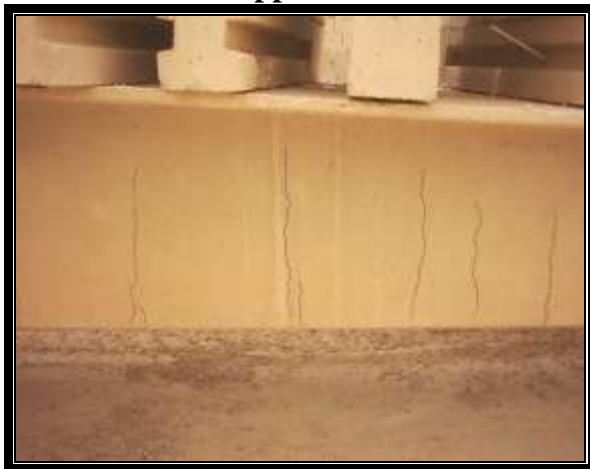
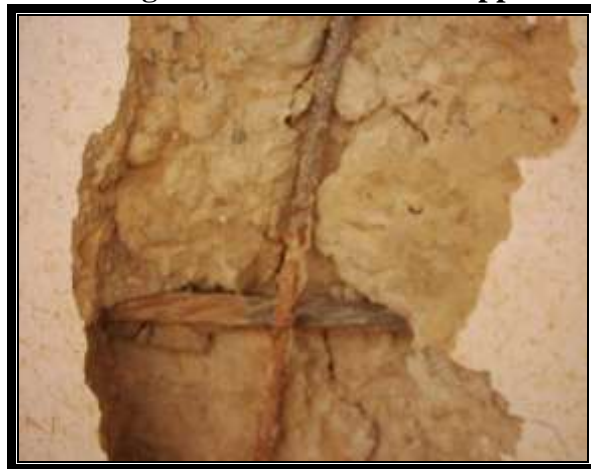
Fig. (17. Beam B2- Crack propagation on beam face side.

a. First crack appeared at 26% of the total beam length measured from the support

c. Final crack appeared at 26% of the total beam length measured from the support

- 3- Flexural failure of the non-prismatic beams B2 and B3 occurred at section located at 26% and 24% of the total length measured from the support respectively.

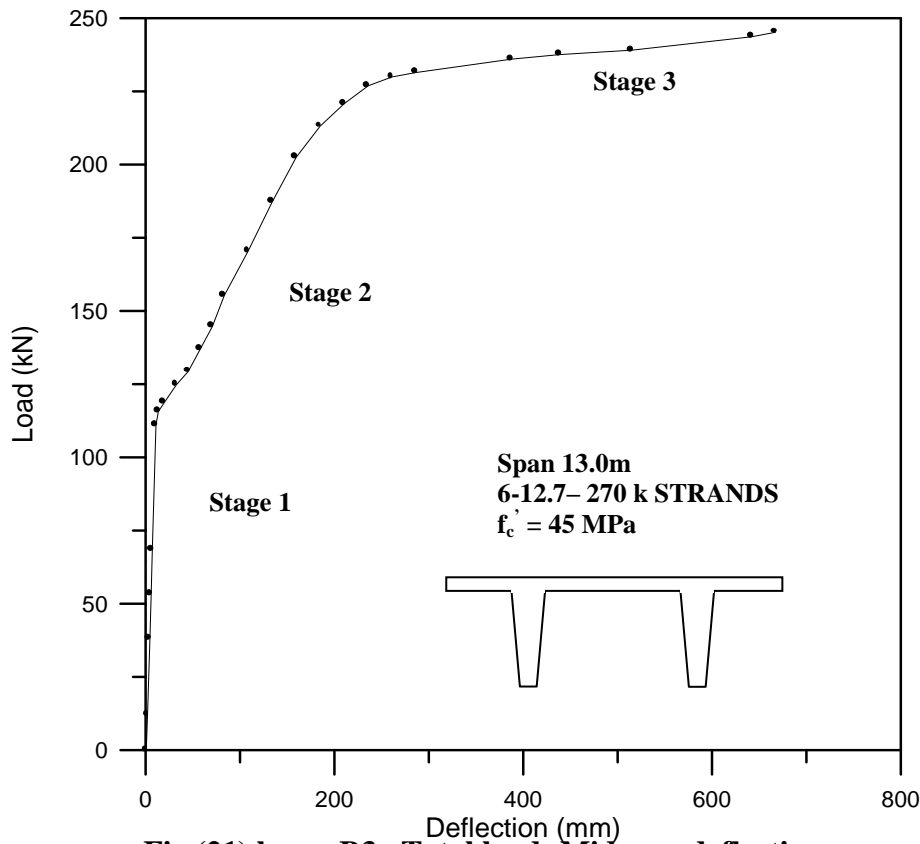
Fig.(21).beam B3 –Total load- Midspan deflection response.

Displacements were measured at both ends and at the center of the span during the test. Figure (21) shows the load-midspan deflection curve.

Three distinct stages of behavior could be identified as, stage 1 which corresponds to the uncracked state of the beam when it behaves as a linear elastic member. This elastic behavior stage is terminated by onset of cracking at the pure bending zone at a load level of 116kN. The cracking load represents about 47% of the ultimate load that equals to 245kN.

Stage 2 followed and continued by the new cracks that were propagated in succession with an increase in the applied load. Such cracking reduces the beam stiffness, but the load deflection curve remains essentially a straight line indicating elastic response of cracked sections.

Stage 3 is characterized by a rapid decrease in the slope of the load deflection curve with slight increase of load levels. It commences with the formation of a plastic hinge, and since the beam was simply supported, theoretically the beam should continue to deform at the same load until the rotation capacity of the plastic hinge is exhausted. However, this beam exhibited slight increase in the applied load after yielding of steel had occurred.

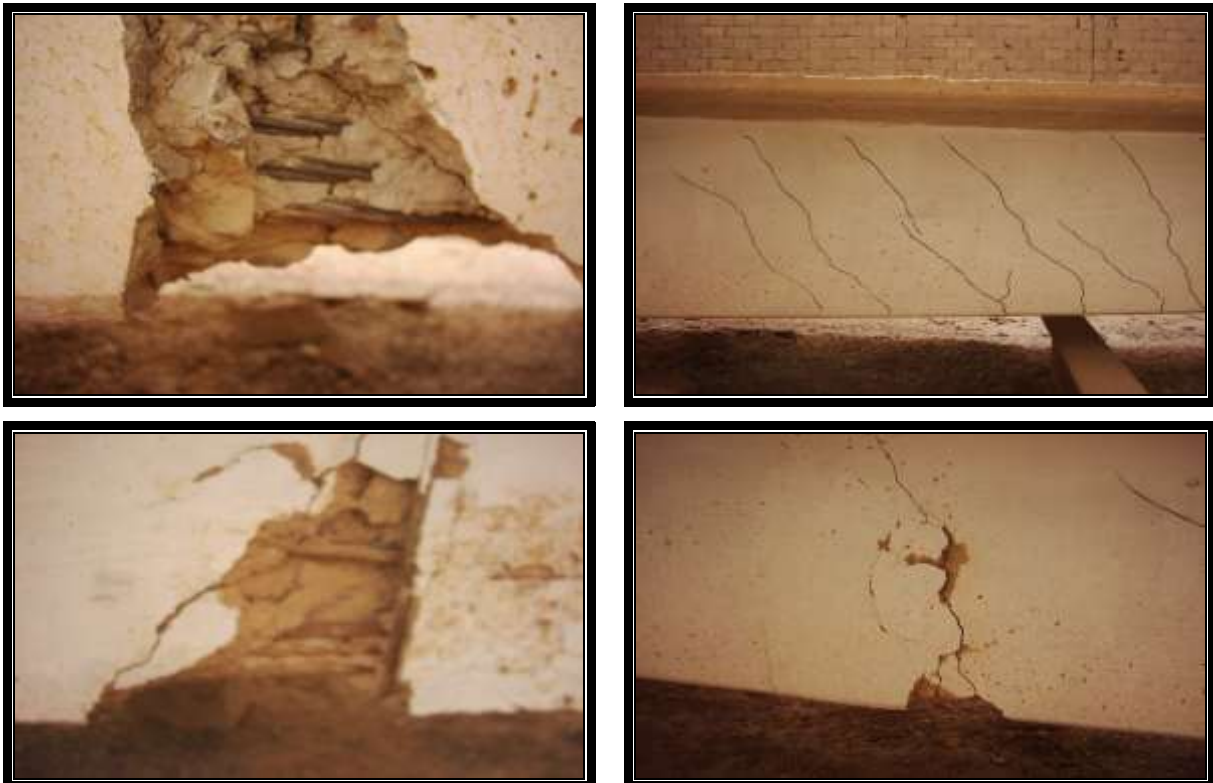
Fig. (22). Beam B3- Crack propagation on beam face side.

These hair cracks did not propagate during the progress of the testing. Flexural cracks were observed first at midspan, which propagate upward with increasing the testing load. The flexural cracks become wider until flexural failure as shown in Fig. (22).

The final failure cracks were indicated at a distance equals to 24% from total beam length measured from the support. Figure (22) shows first appear and final crack propagation indicated with increasing the load up to failure.
