AN APPRAISAL AND ANALYSIS OF BOILER PIPES IN AL-MUSAIB ELECTRIC POWER STATION

ABSTRACT

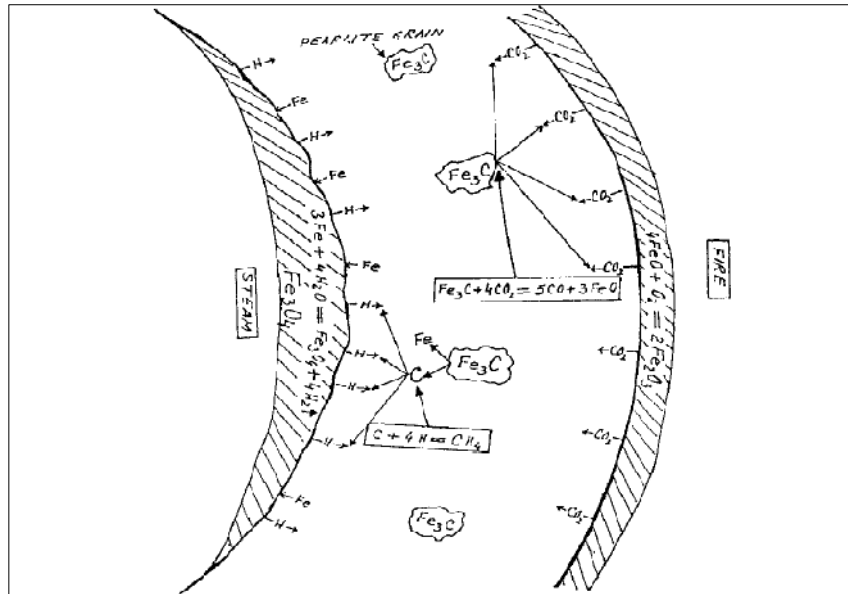
An illustration of the environment that results in hydrogen damage is shown in **Fig. (8)**.

Figure (8): Schematic representation of expected hydrogen damage mechanism in boiler tube. [5]
