Torsional Strengthening of RC Beams with CFRP Wrap

Civil Engineering Department, University of Mosul

Abstract

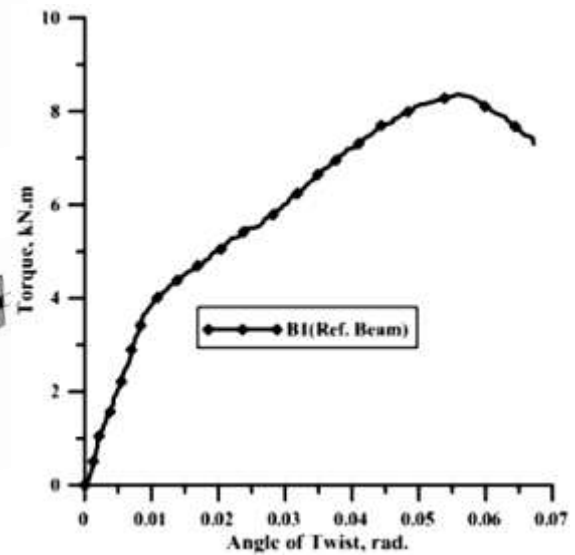
Figure(4): Torque-twist behavior for the unstrengthened beam B1.

Figure (4) shows the reference beam torque-twist behavior. The diagonal cracks first appeared at the middle of the vertical faces with an applied

cracking torque equal to 4.0 kN.m. The cracks then propagated into the horizontal faces in a spiral form. An examination of the torque-twist curve reveals that the beam behave sensibly elastically before initial cracking. The cracks gradually widened at the middle test span as load increased with the two beam segments rotating relative to one another about the horizontal axis where spalling and crushing of concrete took place just prior to failure (Figure 5). The beam reached an ultimate torque of 8.36 kN.m and exhibited a ductile behavior due to the amount of reinforcement provided, which is greater than the minimum reinforcement required to avoid the failure of beam at cracking^[10].

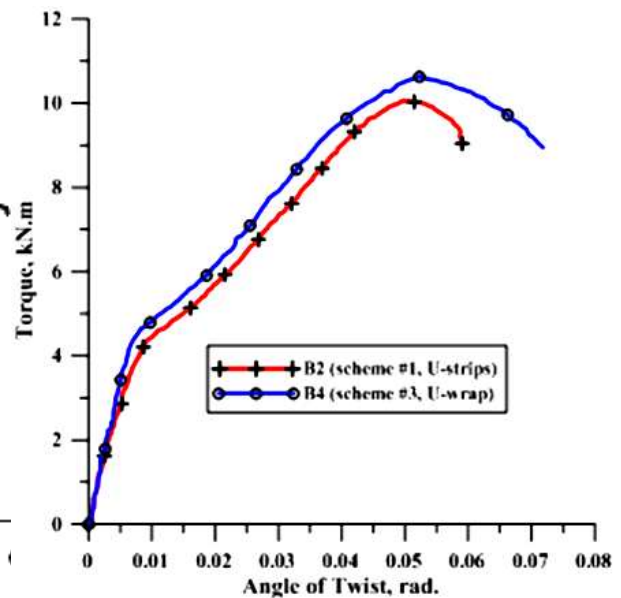
Figure (10) Torque-twist behavior
Effect of U-wrap over U-strips.

The behavior of B4 to the ultimate strength is similar to beam B2 and sustains ultimate torque very close to that of B2 (Fig. 10). During loading, the cracks created on the top face of the beam (where it is not wrapped by CFRP) are gradually opened in a skewed form and finally failure took place with debonding of the CFRP jacket at free edges (Fig. 11) and ultimate torsion equal to 10.63 kN.m. The reason for the deficiency strengthened beams B2 and B4, using U-strips or U-wrap, is that the CFRP free edges were not provided with anchorages.

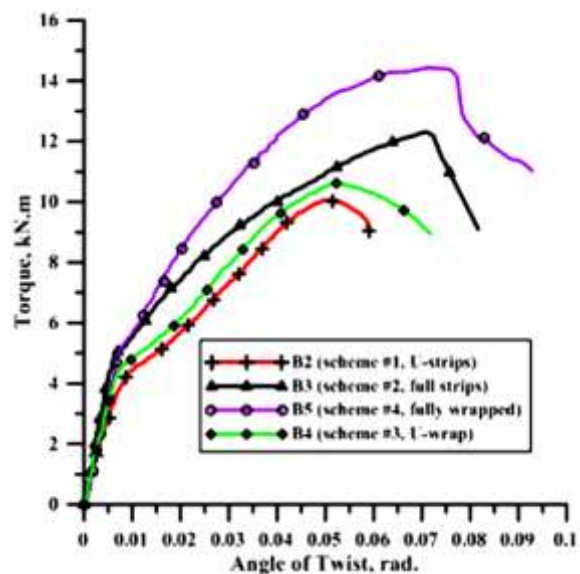
Figure (12).Torque-twist behavior:
Effect of fully-wrapped over other schemes.

Figure (12) shows that the fully wrapped of the torsion region of a reinforced concrete beam is more effective in increasing the torsional strength of the beam B5, compared to beams strengthened by other schemes. The initial cracking torque as observed from torque-twist behavior in Figure (12) appears to be 5.0 kN.m. Using the CFRP full wrapping, the ultimate torsion increased 73% more than the reference beam B1. The fully wrapped CFRP strengthening confined the concrete which improved the concrete strength, prevented the cracks from widening, delayed the failure and finally resulted in a significant increase in the

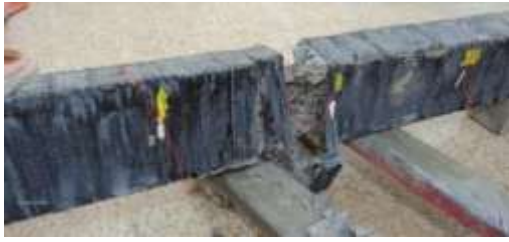
Figure (13) Crack pattern at failure for beam B5.

ultimate deformation. Beam B5 failed at an ultimate torque value of 14.44 kN.m with excessive concrete crushing followed by CFRP rupture at mid-span, as shown in Figure (13).

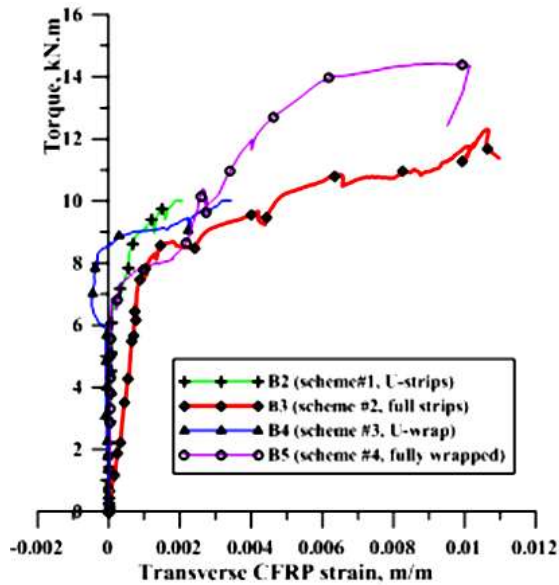
Figure (14) Torque versus CFRP strain in transverse direction.

The CFRP strains, in transverse and longitudinal direction, along the principal fiber direction on the middle test span were measured. Fig. 14 shows the experimental results in terms of torque versus CFRP strain in transverse direction. The strain does not vary until cracking occurs, widens and propagates. By qualitative study of Fig. 14, it can be seen that CFRP strain levels corresponding to beams **B2** and **B4** less than those of the beams **B3** and **B5**. These differences are attributed to beams failure modes. The failure of beams **B3** and **B5** is mainly characterized by fiber rupture, whereas beams **B2** and **B4** exhibited premature debonding. The strain of the fibers could be used as an index for the effectiveness of the FRP fabrics, since it represents a rate of fibers utilization in beams strengthening.
